CAPITAL RESERVE STUDY – DRAFT
VILLAGE OF FOUNTAINVIEW
FOUNTAINVIEW CIR AND FOUNTAINVIEW DR
NEWARK, DE 19713

FOR:
VILLAGE OF FOUNTAINVIEW CONDOMINIUM ASSOCIATION
c/o MARY TUCKER
COMMUNITY MANAGER

JULY 21, 2020

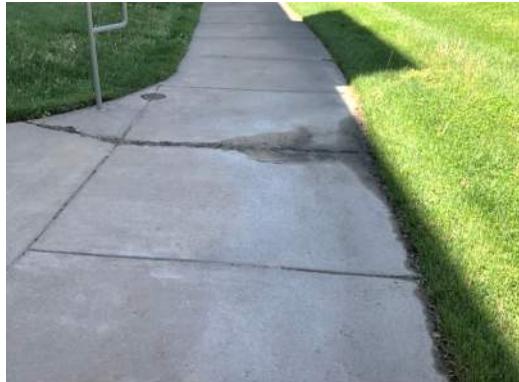
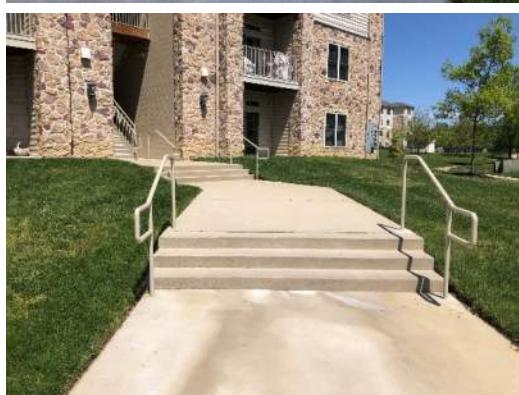
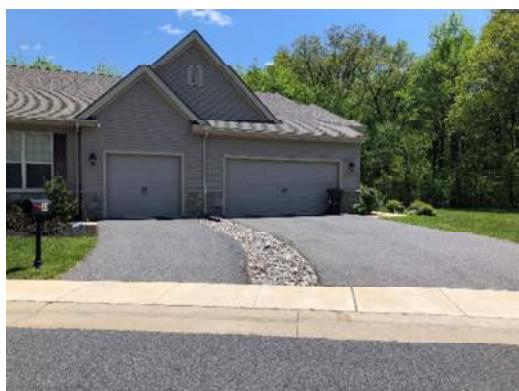
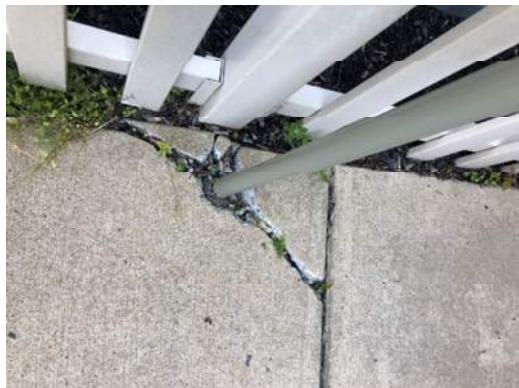
The sidewalks, curbs, and paving are generally in good condition with some pre-mature cracking and spalling observed in the concrete. O&S observed railing post pockets spalling within the concrete sidewalks and stairs. O&S noted several areas of concrete deterioration were repaired or replaced.

Preventative maintenance including power washing to remove deicing salts, seal coating asphalt, sealing concrete cracks, and selective curb repairs should be performed regularly to extend the service life of the paving components. Deteriorated flags of concrete should be replaced as needed.

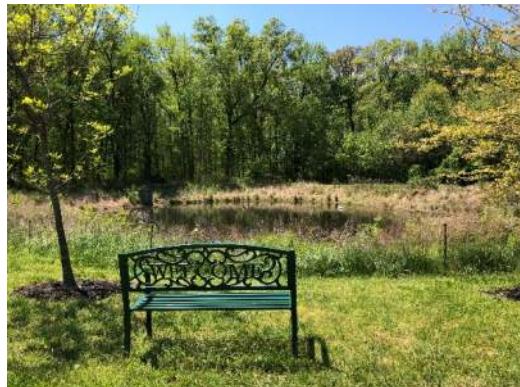
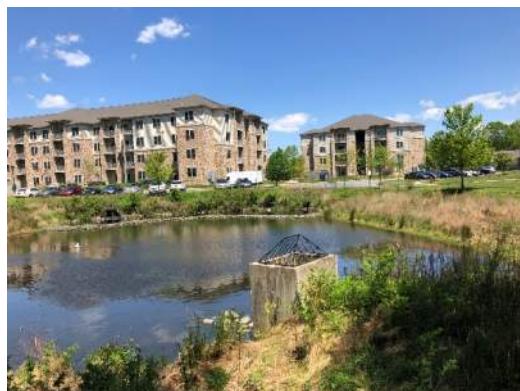
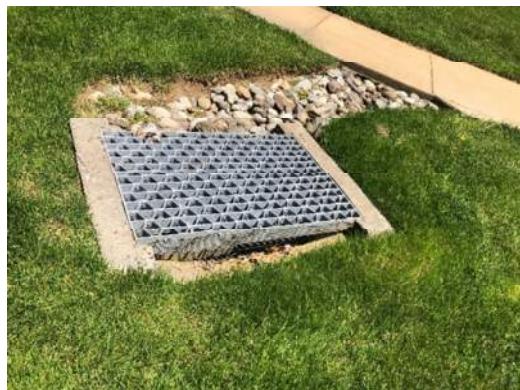
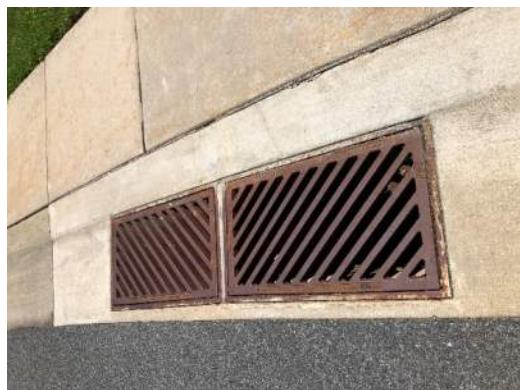
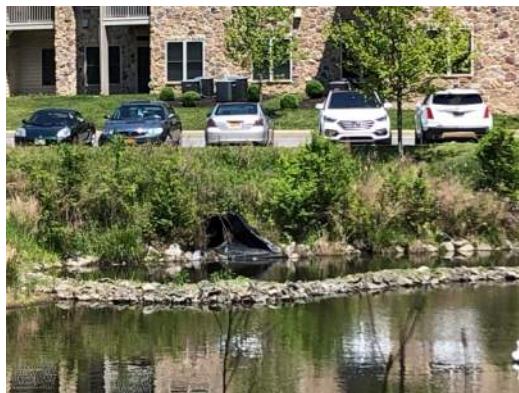
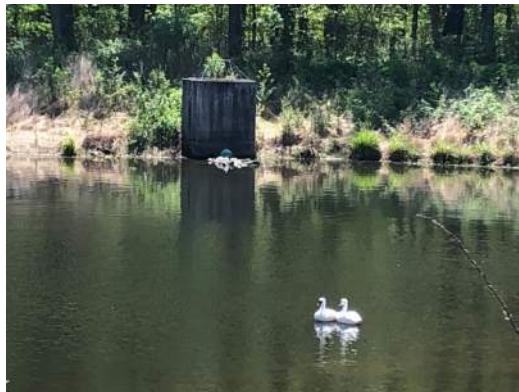
The storm drains and retention pond appeared to be in good condition with a typical amount of wear and tear that can be expected for age of the current installation. The ground around the drain between the 1000 and 2000 buildings appears to be eroding, causing a tripping hazard.

Regular cleaning and maintenance of the drains, riprap (stone), inlets, and outlets is recommended to maintain the retention pond.

The board may want to consider adding another drain or regrading the sidewalk to minimize the amount of ponding behind the 1000 building. Additional investigation is required to determine the best course of action as this is outside of the scope of this study.

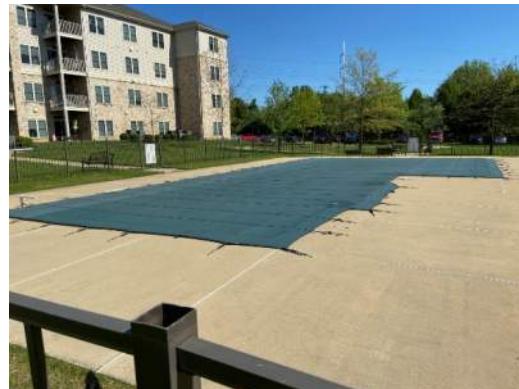
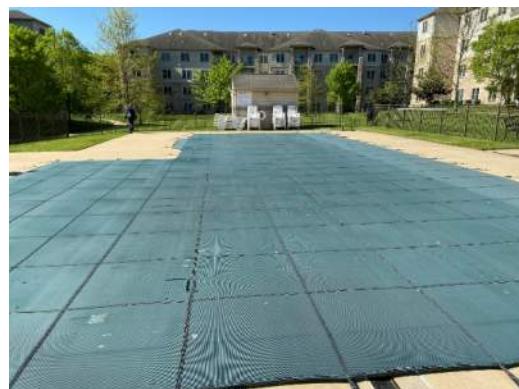
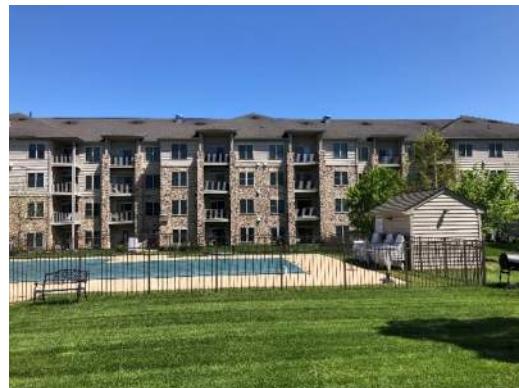
At the time of the visit the pool cover was on so O&S was not able to directly observe the condition of the pool. The board has reported the pool to be in good condition. The board plans to replace the pool cover next year.

The pool fencing appeared to be in good condition.

The pool should be resurfaced every 20 years with regular maintenance between resurfacing. O&S anticipates resurfacing the pool in approximately 8 years however future assessment may further extend its life expectancy based on its performance.

Regular maintenance and repainting of the metal fence is recommended to extend its useful service life.

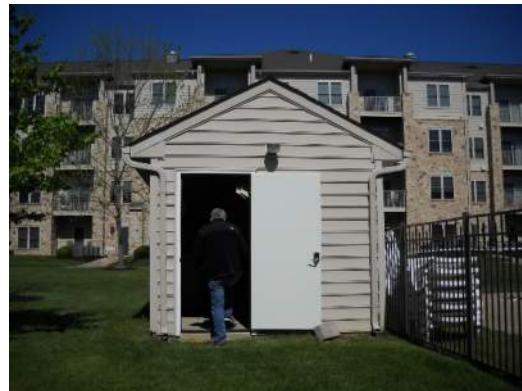
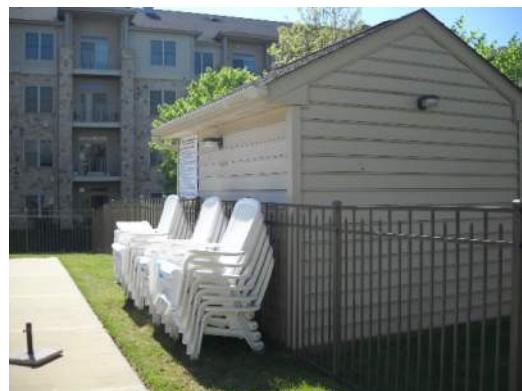
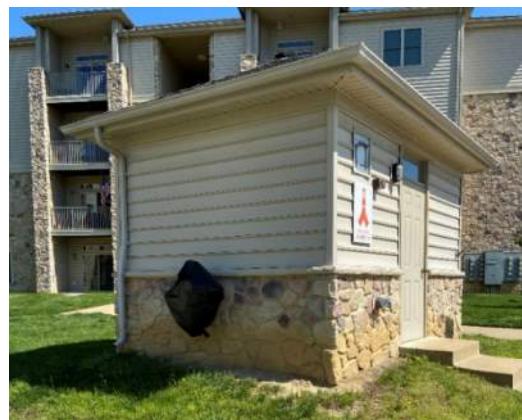
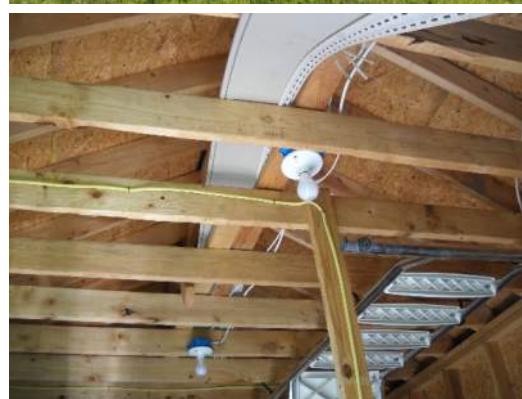
The pool and fire buildings are in good condition with a typical amount of wear and tear that can be expected for age of the current installation.

Preventative maintenance at these buildings should be performed regularly to extend their service lives.

Repairs, replacements, and/or upgrades are recommended every 25-30 years to address any deteriorated components. The vinyl siding and asphalt shingle roofing is expected to be replaced in 13 years.

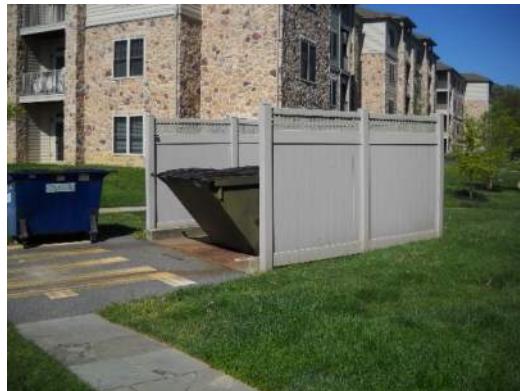
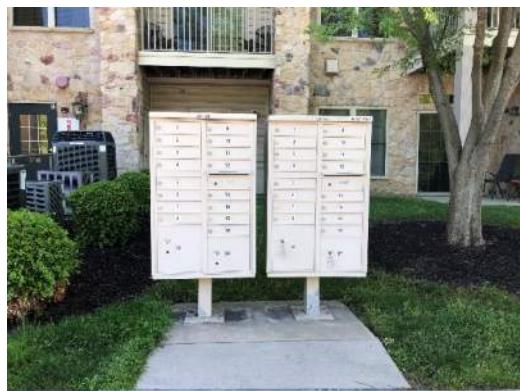
The vinyl fencing was in good condition with typical wear and tear for its age. The dumpsters and kiosks were in fair condition. The board reported the township has directed them to replace the dumpsters, due to their condition. The kiosks were observed to have paint chippings and metal corroding at the base.

It is recommended to replace dumpsters and mail kiosks every 10 years. General maintenance and repainting of the mail kiosks can extend their useful service life. The mail kiosks are generally in good condition and we have, therefore, extended their life expectancy by an additional 5 years.

Fencing around dumpsters typically has a shortened service life. Therefore, we have estimated the life of the vinyl fencing to be around 20 years. Replacement of the vinyl fencing is recommended in 8 years.

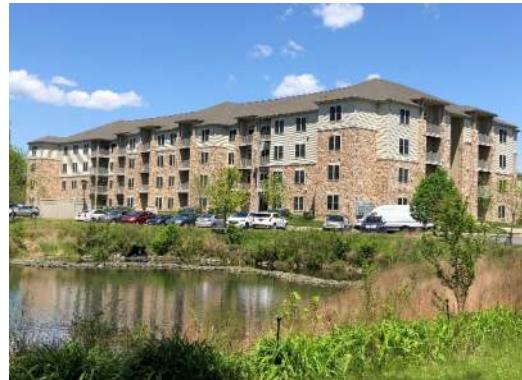
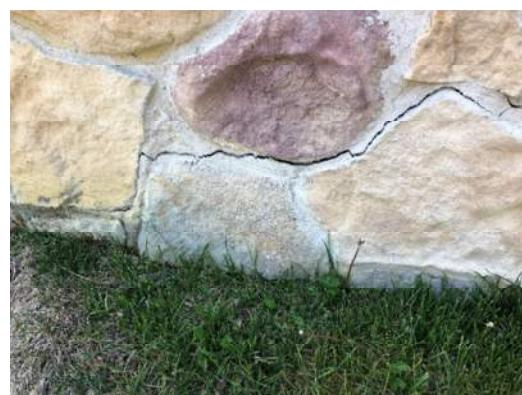
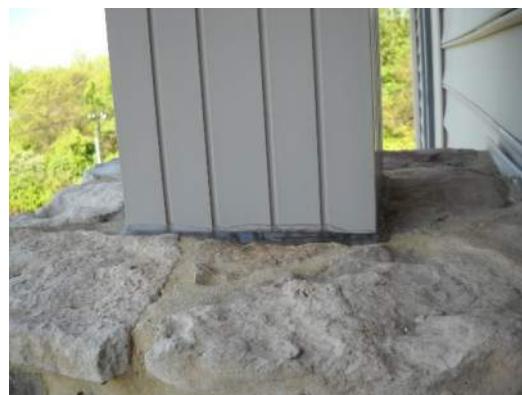
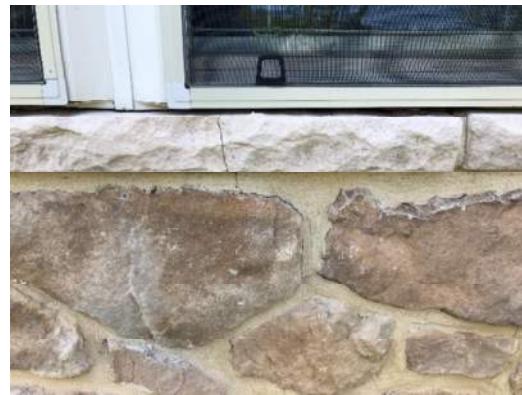
The exterior walls appear to be in generally good condition with localized areas of concern. O&S observed typical cracking though the stone veneer mortar joints from settlement. Localized areas have already been repointed. O&S noted the stone veneer is installed below grade (ground) level. Industry standards recommend the veneer be installed above grade level. This may reduce the life expectancy of the veneer.

The board reported insufficient flashings were discovered in the 2000 building at the transition from the siding to stone veneer. A repair program was undertaken to correct the flashings in the 2000 building. This condition presumably also exists in the 1000 and 3000 building and remains to be repaired.

While reviewing the balconies, O&S observed the coping at the stop of the stone piers is not sloped to drain properly. Additional sealant had been added to minimize water infiltration through the central post.

Further investigation into the flashings at the 1000 and 3000 buildings is recommended to confirm conditions prior to a repair program. If similar flashing deficiencies exist in these buildings, a repair program is recommended to mitigate any potential water infiltration.

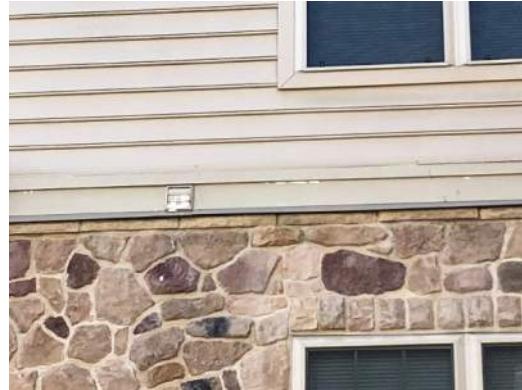
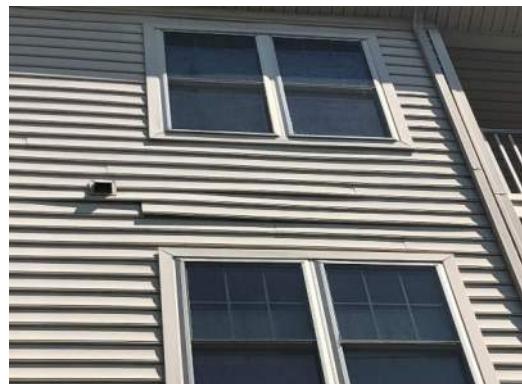
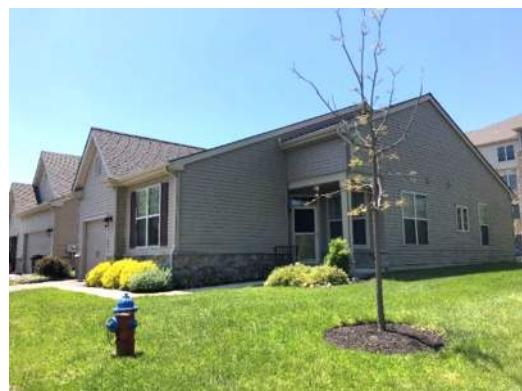
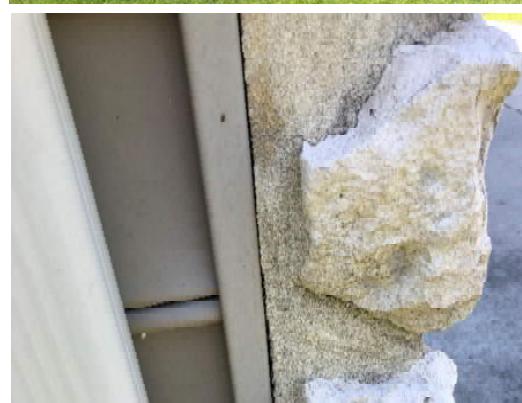
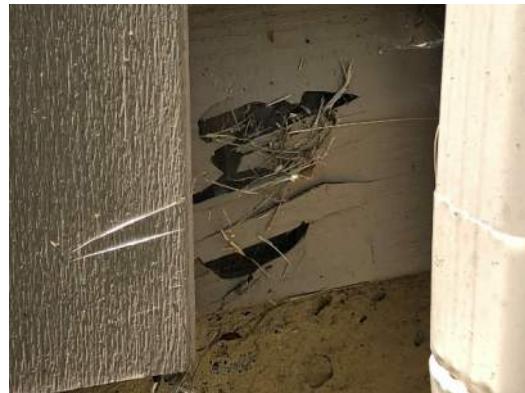
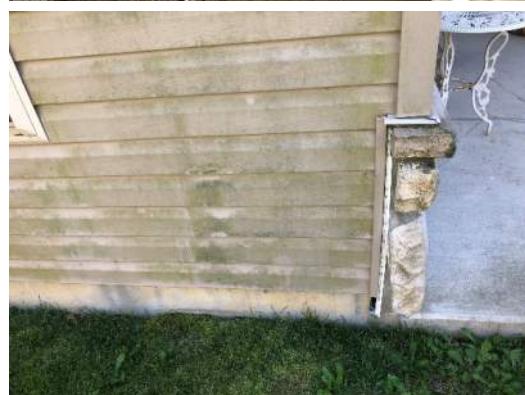
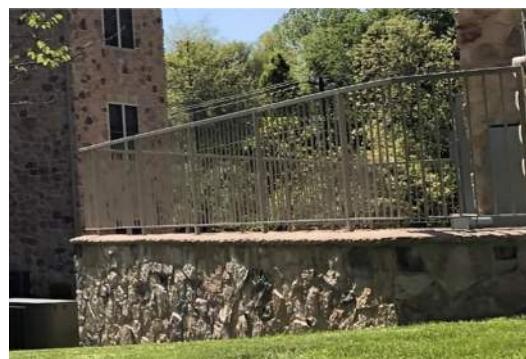
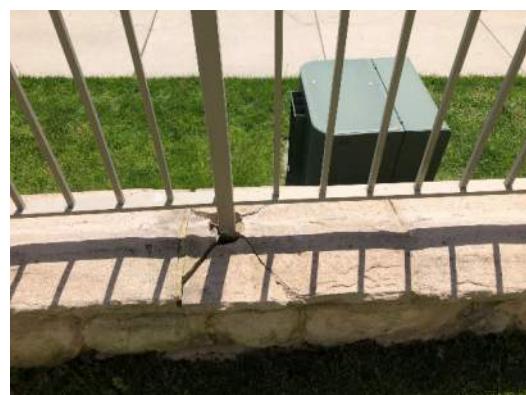
O&S observed localized displaced, damaged, and warped pieces of siding around the property. O&S noted typical plant growth on the siding on North facing elevations.

O&S noted there were no sealant joints in the masonry stone veneer.

The board has stated their vent covers do not keep birds out. O&S observed the birds lifting the vent flaps to enter the vents. The board is planning a vent cover replacement program.

The site wall masonry veneer was observed to be experiencing similar deterioration to the buildings stone masonry veneer. The fencing post pockets are deteriorating, causing the stone copings to crack.

Displaced siding should be reset where possible. Damaged siding should be replaced in kind. O&S recommends cleaning the vinyl siding regularly to remove plant growth.

Post pocket repairs are recommended at the site wall fencing. Cracked copings should be repaired or replaced to maintain the weathertightness of the site wall.

O&S noted there were no sealant joints in the masonry stone veneer. It is typically recommended to install sealant joints at the interface between the stone veneer and dissimilar materials (windows, doors, etc.). This is outside of the scope of this study, but O&S recommends these joints be replaced with sealant joints when the veneer is replaced.

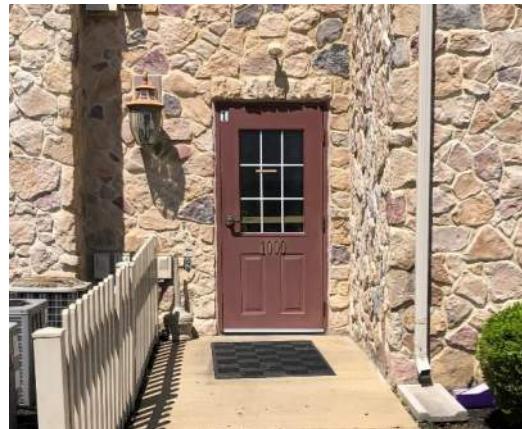
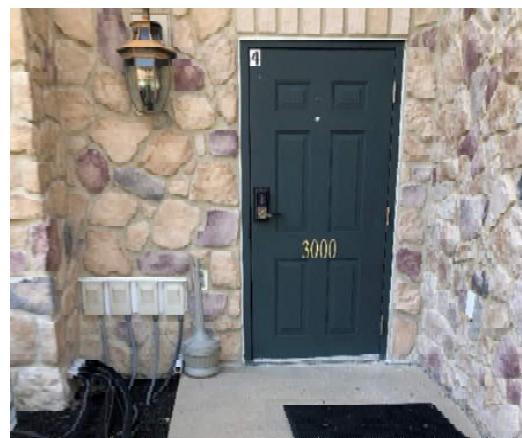
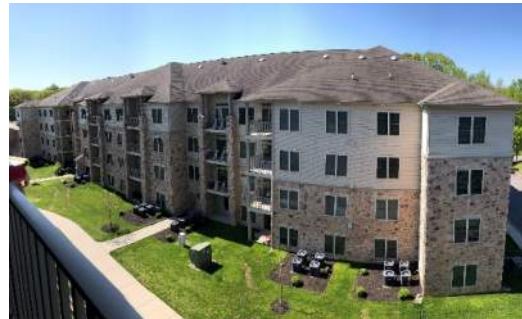
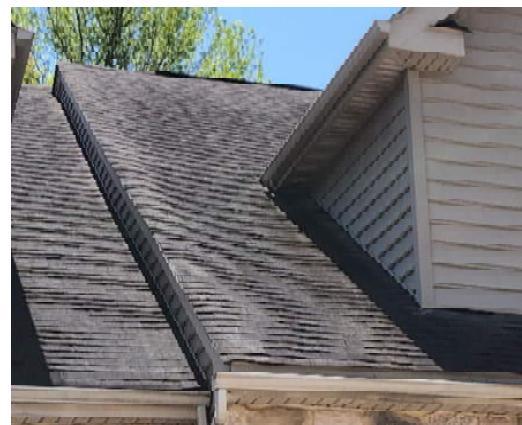
The exterior doors and roof systems appeared to generally be in good condition. O&S observed plant growth on the roof of the oldest townhome building. The board reported they have had to replace localized shingles.

Exterior doors have an expected useful life of 25 years, after which time replacement is recommended. Replacement of the exterior doors is recommended in approximately 12-13 years.

The expected life of asphalt shingle roofing is 25 years. Therefore, replacement is not expected for at least 12 years. Removing any plant growth is recommended to extend the service life of the roofing.

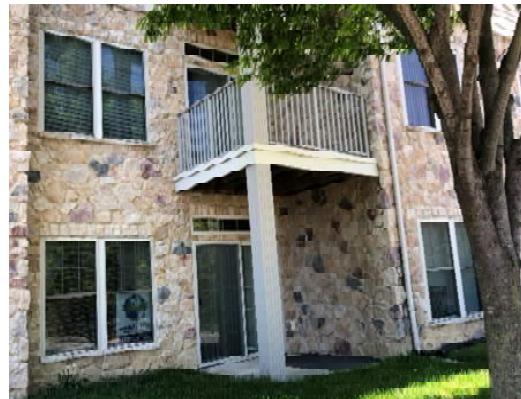
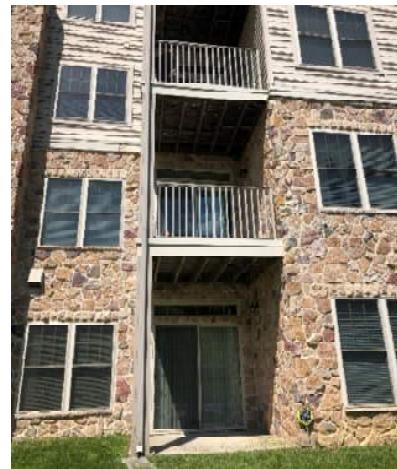
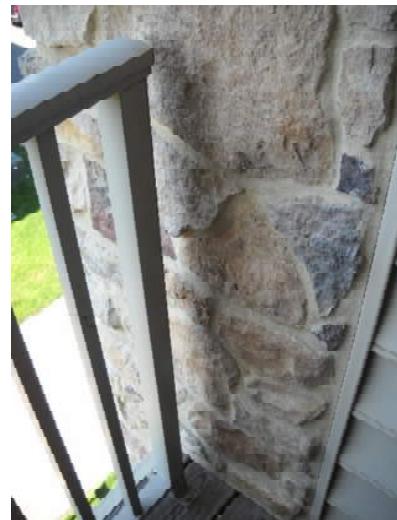
The balconies and patios are in good condition with a typical amount of wear and tear that can be expected for age of the current installation. O&S noted that the railings mounted to the wood balconies appeared to be somewhat loose. Note that the railings are only attached to the wood deck and have no attachment to the walls.

General maintenance of these components should be performed regularly. Metal railings should be repainted regularly to remove any existing corrosion and mitigate the potential for further corrosion.

Wood balconies and decks have a typical expected useful life of 20 years, therefore replacement can be anticipated in 7-8 years. However, the balconies are generally in good condition and we have, therefore, extended their life expectancy by an additional 5 years. Future assessment programs should further validate their continued good performance and durability.

O&S recommends that the railing attachments be checked to ensure that they meet minimum code requirement for lateral resistance.

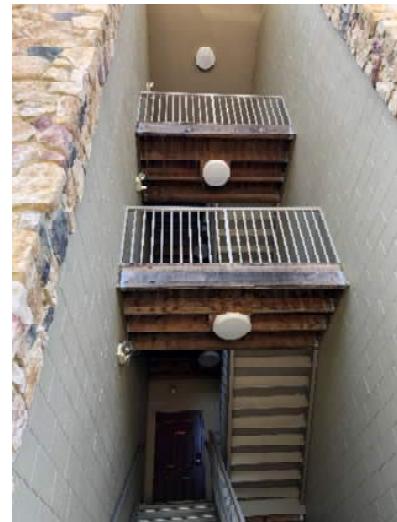
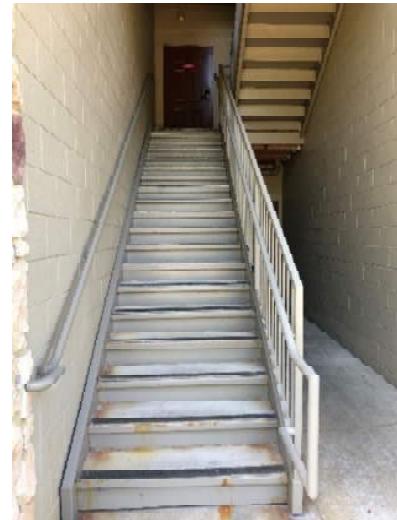
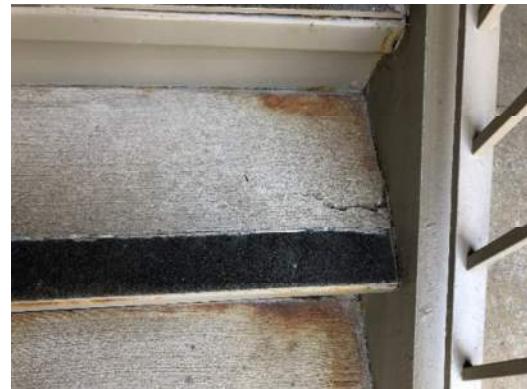
The stairwells were generally in good condition. O&S noted some minor rust staining from corroding metal and localized spalled concrete at the bottom of the ground floor stairwells. The bottom of the stairwells are not as protected as the remaining area of the stairwell as they are closest to the exterior.

General maintenance of the stairwell should be performed regularly. Metal railings and stairs should be repainted regularly to remove any existing corrosion and mitigate the potential for further corrosion. Spalling concrete should be repaired as needed.

Exterior wood stairwell landing decking has a typical expected useful life of 20 years, however, due to being mostly enclosed, this service life will likely be longer. O&S anticipates replacement of wood landings in 7 to 8 years. However, the balconies are generally in good condition and we have, therefore, extended their life expectancy by an additional 5 years. Future assessment programs should further validate their continued good performance and durability.

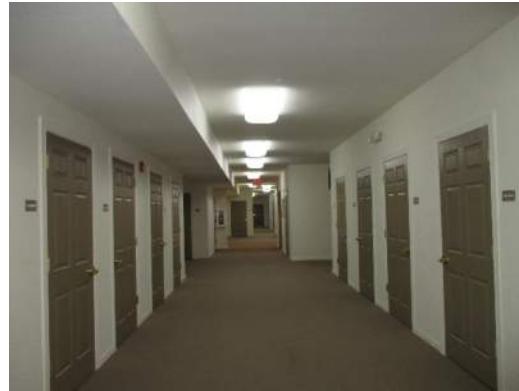
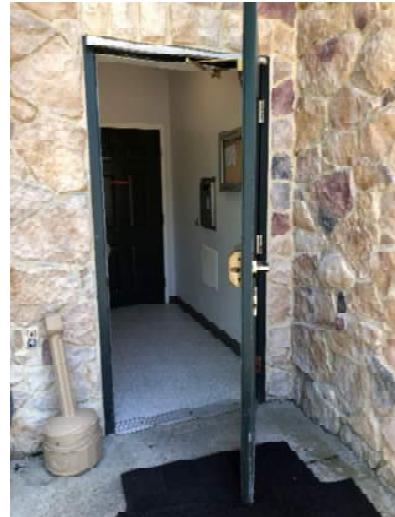
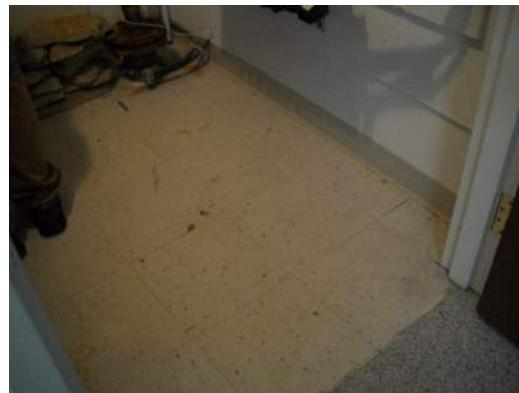
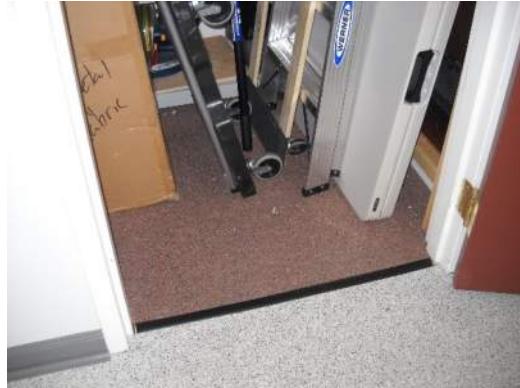
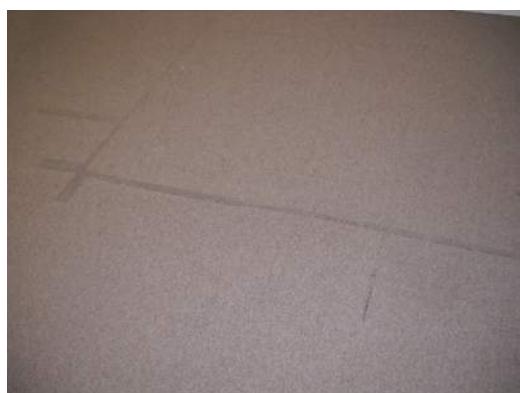
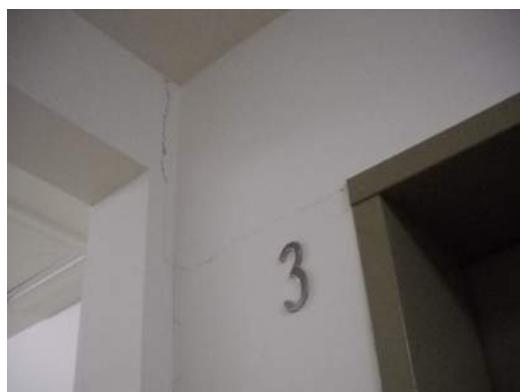
The vinyl flooring and doors were generally in good condition with a typical amount of wear and tear that can be expected for age of the current installation. The vinyl tile has been installed recently. The carpet was in poor condition with runs and tears in the fabric.

O&S noted settlement cracking in the corridor drywall, typically around the elevators.

Carpet has an expected useful life of 10 years. The existing carpet is original to the buildings and has exceeded its useful life. Replacement is

recommended in the near future. However, replacement is highly dependent upon community expectations, funding, maintenance, and board guidance.

Interior doors should be replaced every 20 years. O&S anticipated door replacement in 7 to 8 years.

Door painting and hardware upgrades should be included as part of a hallway painting/upgrade program. Painting and hardware upgrades are not included in the current reserve expenditures as they are not reserve work scope component. A painting program should also fill in any drywall cracks that have appeared from settlement.

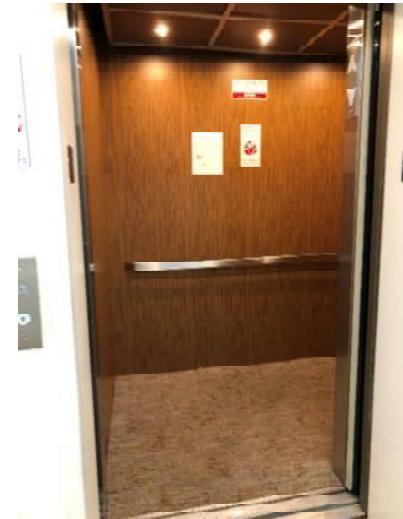
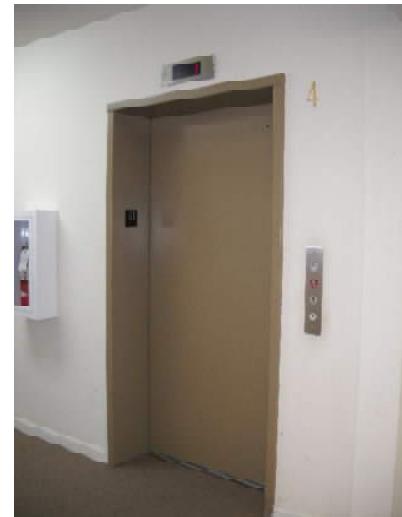
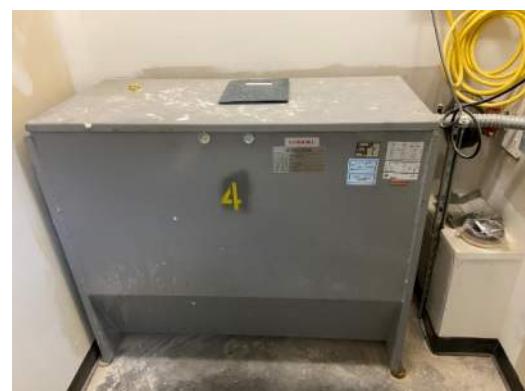
The wood finishes of the elevators were observed to be in good condition. The carpet is nearing the end of its useful service life. The elevator doors appeared to be in good condition. The elevator mechanical controls appeared to be well maintained and in good working condition.

Renovation of elevator cab interiors is typically recommended to be performed every 15 years, placing the renovation in another 2 to 3 years. The cab interiors are generally in good condition and we have, therefore, extended their life expectancy by an additional 5 years. However, updating the cab interiors is highly dependent upon community expectations, maintenance, funding, and board guidance.

Elevator mechanical control upgrades are recommended every 15 years. Upgrades are anticipated in another 2 to 3 years. However, the elevator mechanical controls are generally in good condition and we have, therefore, extended their life expectancy by an additional 5 years.

Elevators should continue to be serviced and maintained under the current service contract to prolong the expected useful service life.
