**LEVEL 2 REPLACEMENT RESERVE REPORT FY 2026
VILLAGE OF FOUNTAINVIEW**

VILLAGE OF FOUNTAINVIEW

NEWARK, DELAWARE

On-Site Observation Date: December 03, 2025

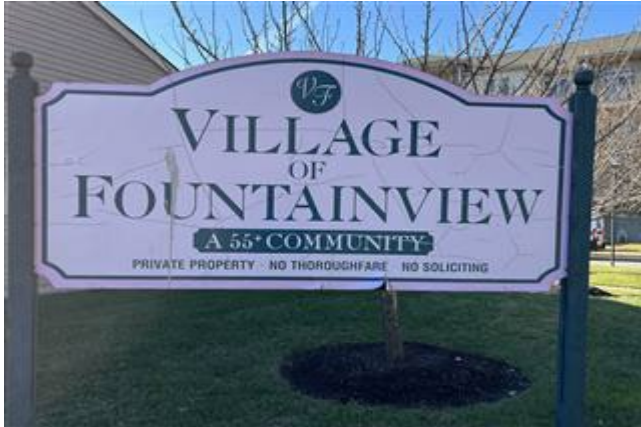
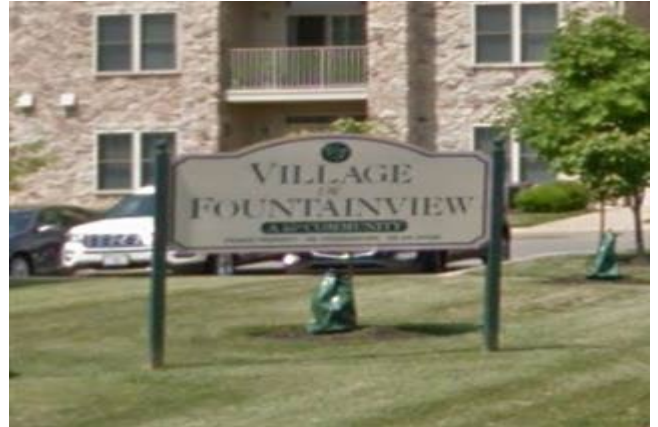
Entry Monument and Signage. The Association maintains an entry sign and posts made of wood and painted lettering. The sign is in fair condition with weathering and some damaged areas. In addition to monuments, the Association is responsible for community signage, including stop, speed, street, and other major signs. This study does not consider other small miscellaneous signs, and those should be replaced using other funds. This study does not consider signs and should be replaced using other funds.

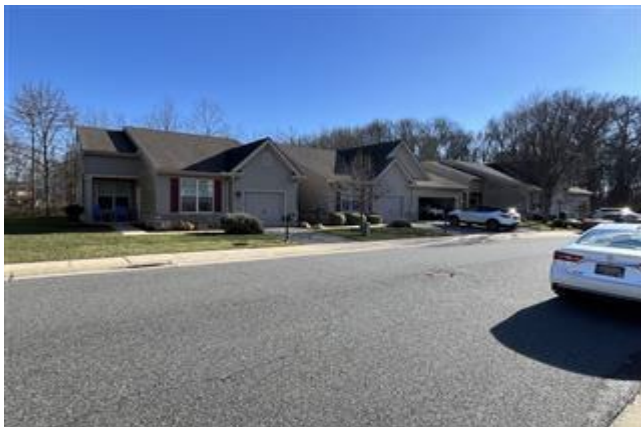
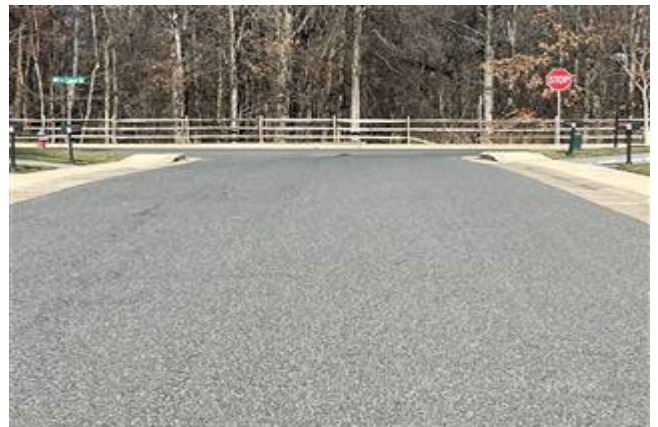
Asphalt Pavement. The Association is responsible for the roadways and parking areas within the community. Alleyways are not the responsibility of the Association. The City, County, or other municipality maintains other roadways. In general, the Association's asphalt pavements appear to be in good condition. A more detailed summary of pavement distress can be found at <https://asphaltinstitute.org/engineering/maintenance-and-rehabilitation/pavement-distress-summary/>.

As a rule of thumb, asphalt should be overlaid when approximately 5% of the surface area is cracked or otherwise deteriorated. The normal service life of asphalt pavement is typically 18 to 20 years. To maintain the condition of the pavement throughout the community and ensure the longest life of the asphalt, we recommend that the Association adopt a systematic and comprehensive maintenance program that includes:

The pricing is based on recent contracts for a two-inch overlay, which reflects the current local market for this work.

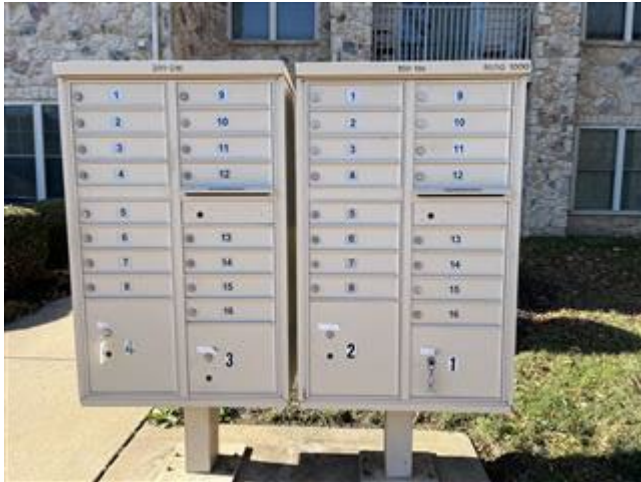
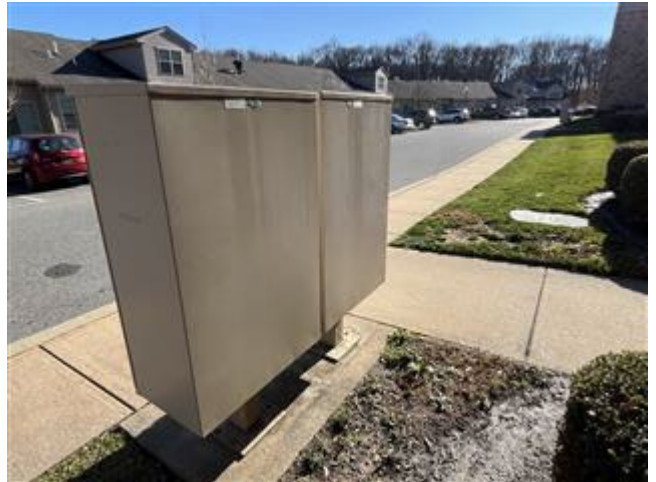
Mailboxes. The Association maintains pedestal mailboxes located throughout the community. The mailboxes include a pedestal and boxes. They are in generally good condition.

Mailboxes should be maintained to the extent that rust does not develop on the structure or pedestal, and all mail slot doors remain intact with operable hinges and locks. Our replacement estimate assumes that these units will be replaced with similar units in the future.

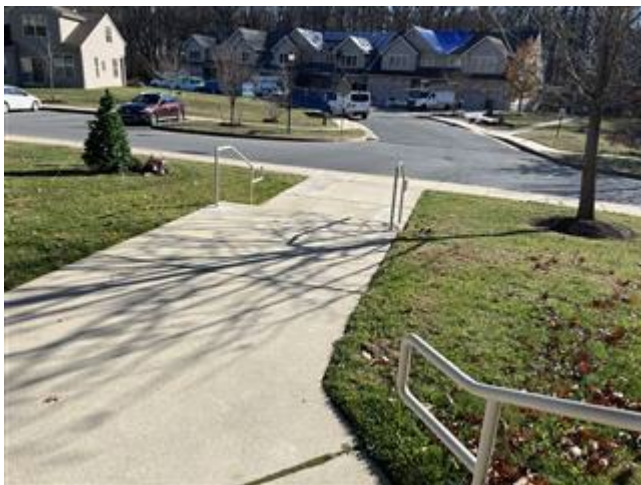
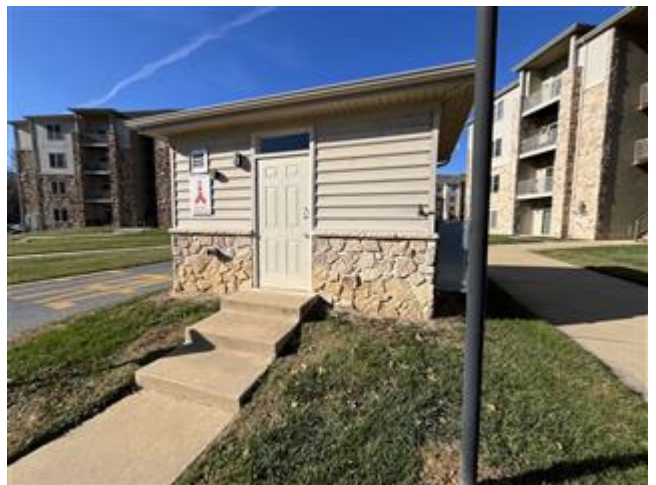
Concrete Work. The concrete work includes the community sidewalks, leadwalks, stairs, stoops, patios, curbs, and gutter as well as other flatwork. We have modeled for curb replacement when the asphalt pavement is overlaid. The overall condition of the concrete work appears to be in good condition, with some noted areas of minor tripping hazards.

Because it is highly unlikely that all of the concrete components will fail and require replacement in the period of the study, we have programmed funds for the replacement of these inventories and spread the funds over an extended timeframe to reflect the incremental nature of this work.

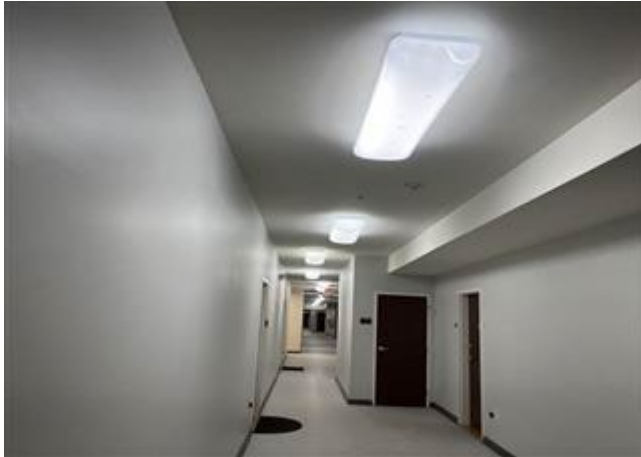
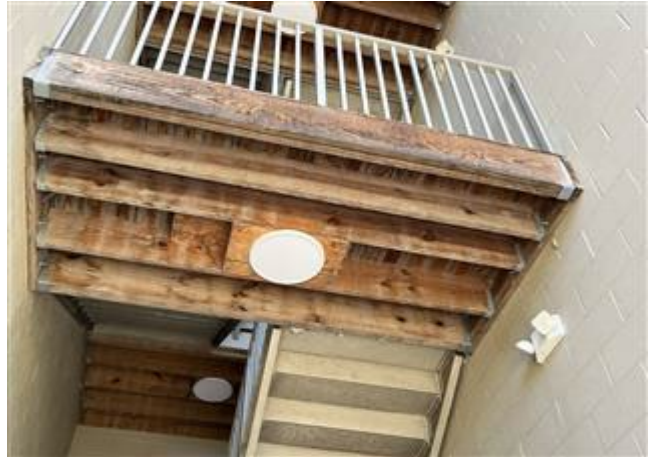
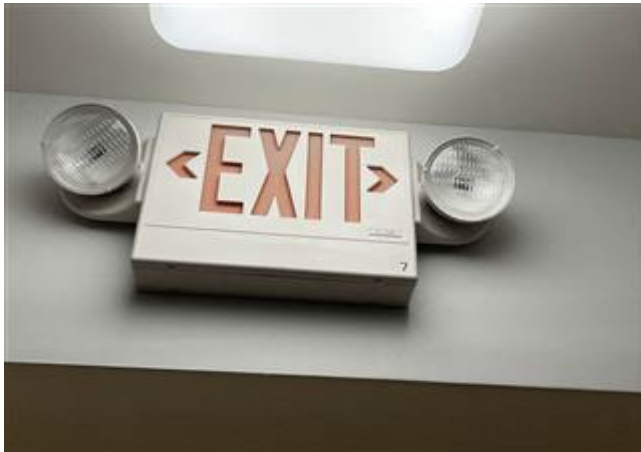
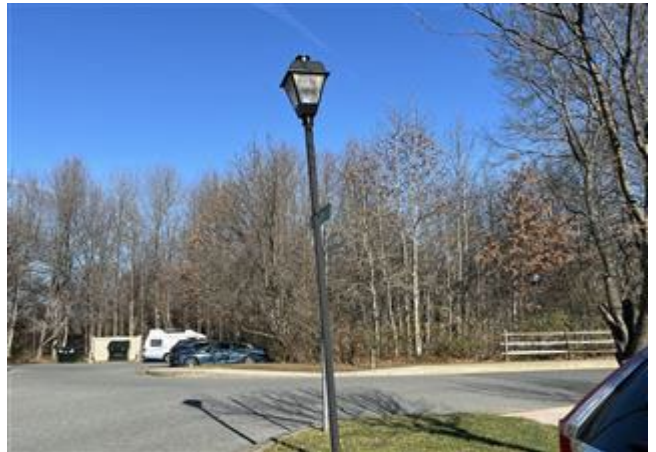
Site Lighting. The Association is responsible for the operation of the communities indoor and outdoor site lighting and appears to be in good condition. The lights were not on at the time of our site visit, but we understand they remain in operating condition.

This study assumes the replacement of the light fixtures every 15 to 20 years and pole replacement every 40 years. We assume that the underground wiring will also be replaced along with the light pole.

When a whole-scale lighting replacement project is called for, we recommend consulting with a lighting design expert, as many municipalities have design codes, guidelines, and restrictions regarding exterior illumination. Additionally, new technology, such as LED and LIFI, among others, should be considered along with factors such as environmental sustainability, longevity, and cost when they look at lighting replacement.

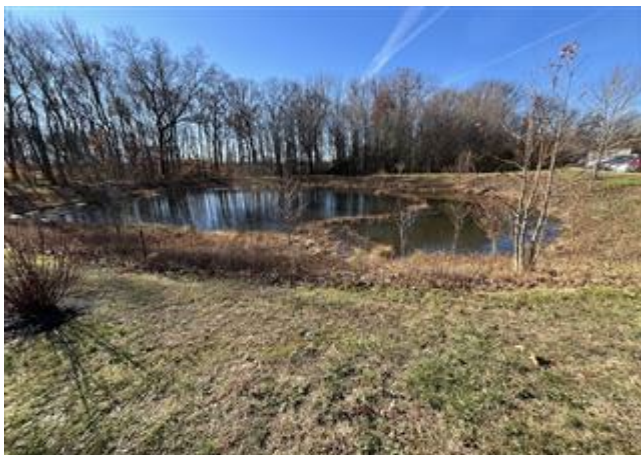
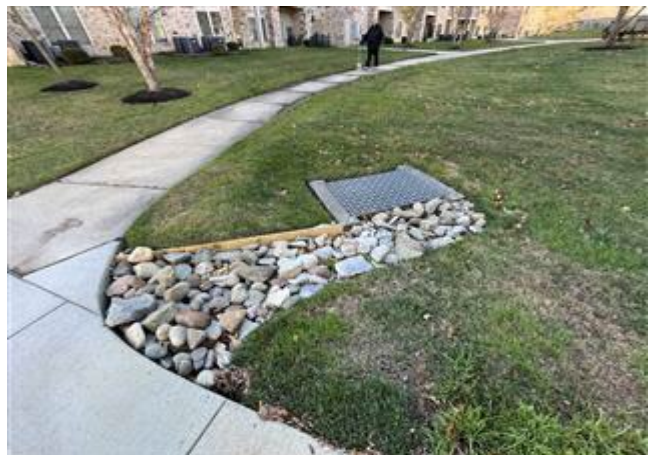
Stormwater Management. The community features stormwater management. The stormwater system consists of surface drainage, structured drainage, erosion control, and runoff. The overall condition of the stormwater management is good, with ongoing maintenance by a certified vendor. The community should maintain the stormwater system to function as designed, limit erosion, and channel water to the drainage system.

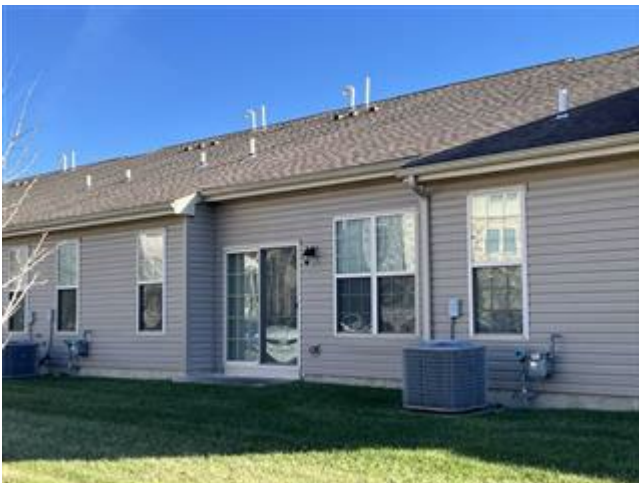
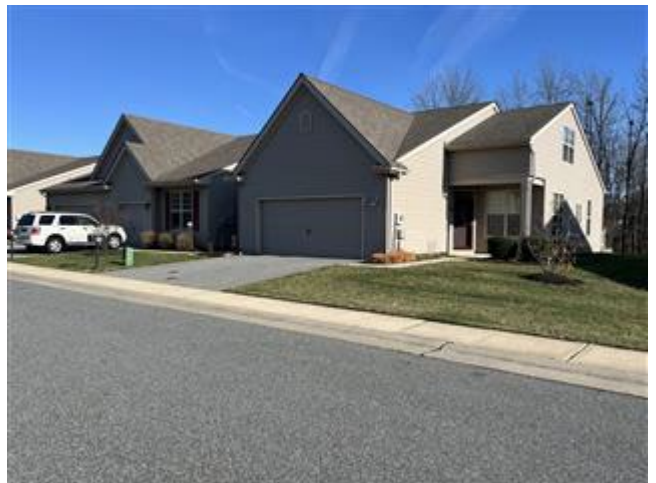
Building Roofing. The Association maintains the roofing for the three (3) condominium buildings, the townhouses and villas. The roofing is in varying ranges of condition. The Association is currently working on establishing a schedule for roofing replacements and/or repairs.

Asphalt shingle roofs can have a useful life of 20 to 50 years, depending on the weight and quality of the shingle. Weathered, curled, and missing shingles indicate they may be nearing the end of their useful life. Access to the roof was not necessary for the visual inspection at the time of the site visit. Annual inspections are recommended, with cleaning, repair, and vegetation mitigation performed as needed. Contractors and personnel should perform access, inspection, and repair work with the appropriate access equipment experienced in the roofing types used for the facility.

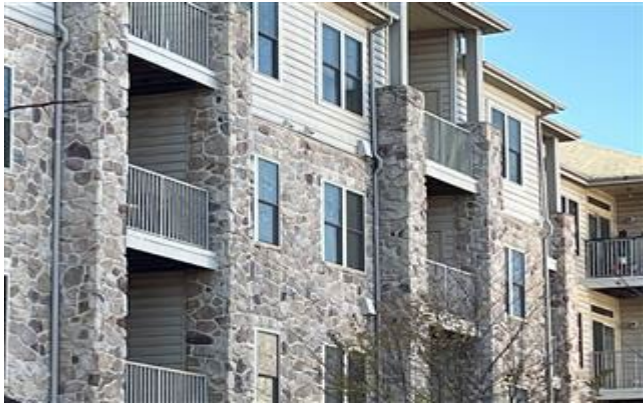
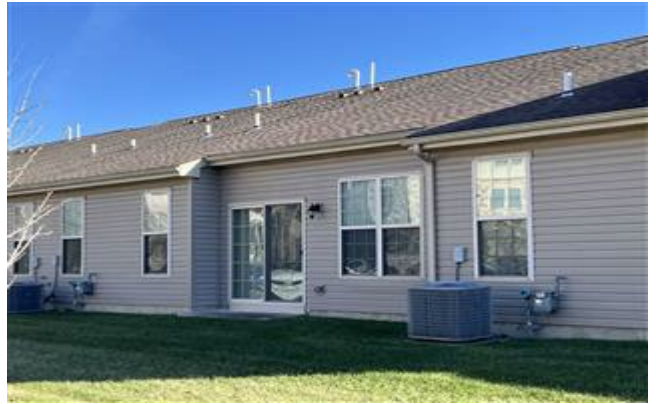
Gutters and Downspouts. The Association maintains the buildings' gutters and downspouts. The gutters and downspouts appear to be in good condition. A gutter and downspout system will remove rainwater from the area of the building's roof, siding, and foundation and protect the exterior surfaces from water damage. Gutters should run the full length of all drip edges of the building's roof. Even with full gutters, it is important to inspect the function of the gutters during heavy rain to identify any deficiencies. It may be necessary to periodically adjust the slope of sections, repair connections, replace hangers, and install shrouds to the gutter system. Downspouts should be securely attached to the side of the structure. Any broken straps should be replaced. The area of the outlet should be inspected to promote run-off in the desired direction. Long straight runs should have an elbow at the bottom. Splash blocks or subsurface connections should be installed to fray the water outletting from the downspout. It is recommended that all gutters be cleaned at least twice each year. If there are a large number of trees located close to a building, consider installing a gutter debris shield that will let water into the gutters but will filter out leaves, twigs, and other debris. Only a limited number of roof sections have gutters and downspouts installed. This lack of gutters and downspouts contributes to the deterioration of the siding, decks, windows, exterior doors, and unit stairs. We also believe that the lack of gutters and downspouts contributes to the erosion and foundation problems that some buildings are experiencing. It is recommended that gutters and downspouts be installed on all buildings. It is also recommended that the discharge from the downspouts be extended at least ten feet away from the foundations.

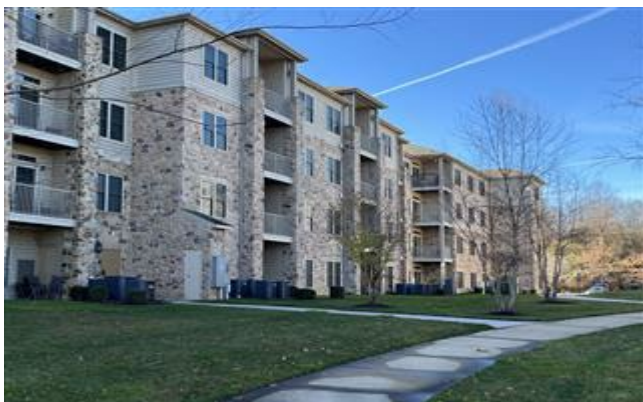
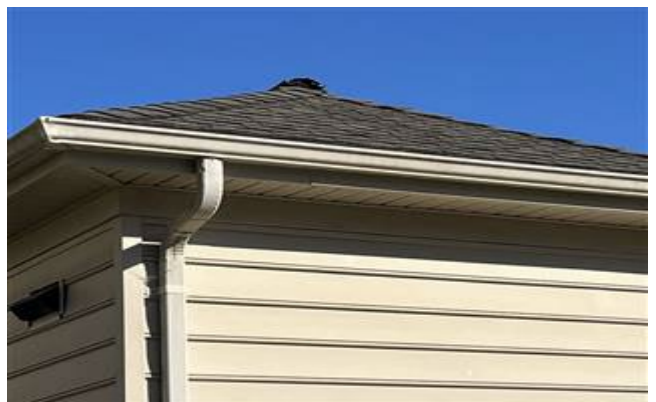
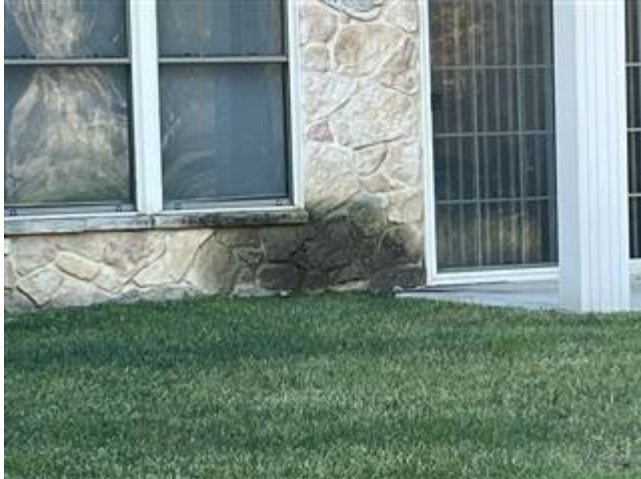
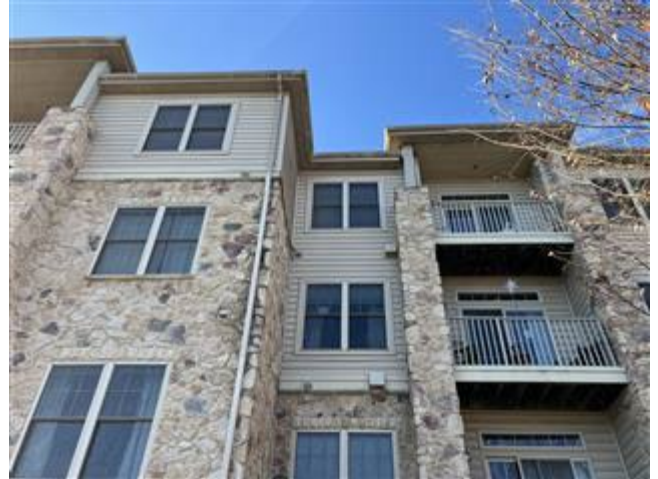
Siding and Trim. The Association maintains the siding and trim for all of the buildings in the community. The vinyl siding appears to be in fair to good condition. The cementitious stone siding appears to be in fair condition, with reported issues with failing underlayment and mold. Some of these failing cementitious areas have been replaced or repaired recently. *The Board is requesting RFP's from local vendors to remove the stone siding and replace with vinyl siding for a longer life and reduced maintenance costs.

*The Association may consider replacements using low-maintenance synthetic or cementitious materials as an alternative to high-maintenance materials.

*Cementitious materials typically have an extended useful life and require repainting and recaulking every 10 to 15 years. Following the manufacturer's recommendations for cleaning, painting, and caulking, we expect cementitious products to have a useful life of 40 years or more.

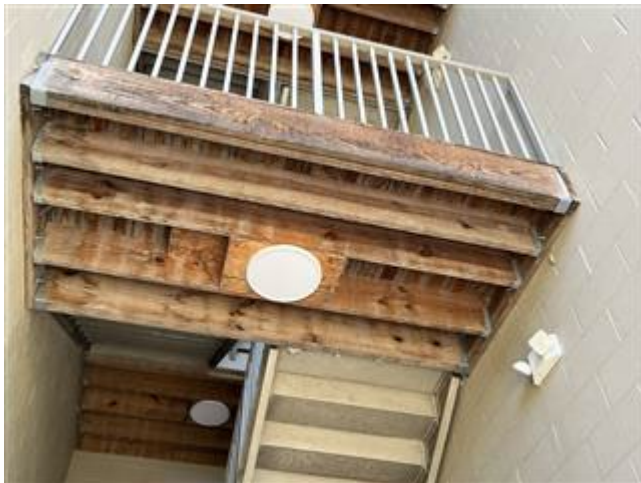
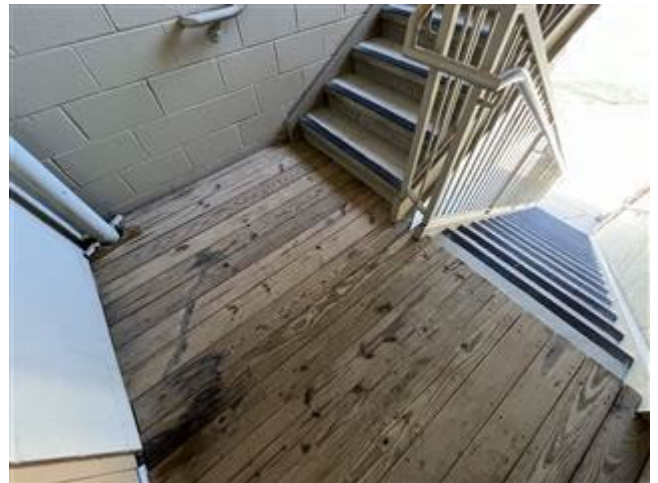
Decks. The Association maintains the wooden (PTL) stair landings and railing of the community. The wooden deck structures appear to be in good condition, and the wooden decking appears in good condition.

We recommend that the Association implement an annual inspection program. We also recommend power washing and the application of a wood sealer with UV protection every two to three years. Installation of carpet or other water-trapping coverings should be prohibited, and potted plants should be placed on raised feet to allow for proper air circulation and drying of wooden components.

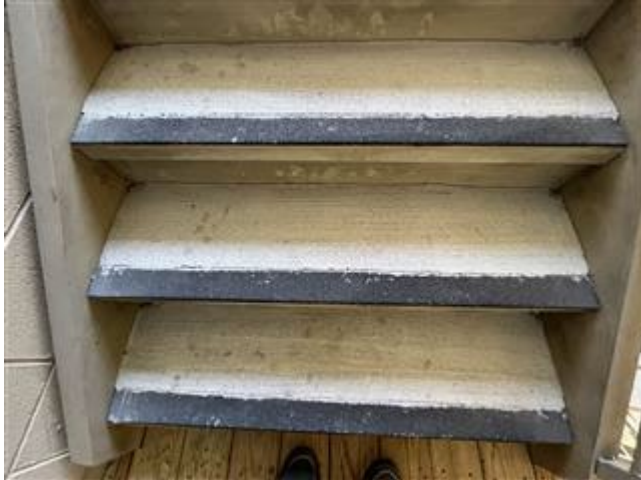
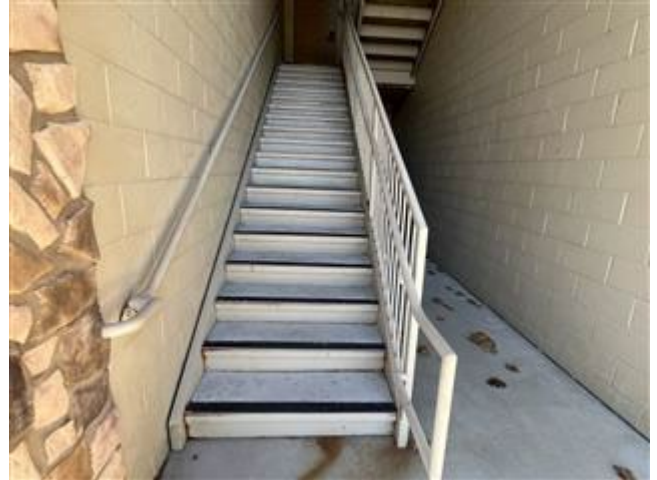
Exterior Concrete and Steel Stairs. The exterior entry stairs of the condominium buildings consist of concrete treads and landings over steel pans. The stairs are in fair condition. There is moderate corrosion on the metal pans risers. A number of concrete treads on the ground floor are cracked or broken. The Board is in the process of getting RFP's for replacing the ground floor entry stairs of the condominium buildings with an alternate structure to revleive that portion of concrete treads and steel pans of further breakdown of materials.

This type of exterior stairs is prone to failure due to corrosion of the steel components and cracking of the concrete treads. The primary reasons for the failure of the metal components are exposed to rain, humidity, salt air, and the use of man-made chemicals to remove ice and snow. The life of the metal components can be extended with attentive maintenance that includes removal of rust while it is still surface rust and regular painting of all metal components.

Concrete treads deteriorate as the result of exposure to the elements, traffic, impact, and chemical exposure. Small cracks develop and allow moisture to penetrate into the concrete where repeated freeze-thaw cycles will cause the cracks to develop further. It is recommended that the Association inspect all stairs at least once each year. All areas with corrosion should be cleaned to remove the corrosion and painted to further protect the steel. It is also recommended that the metal components be placed on a **five-year** paint cycle.

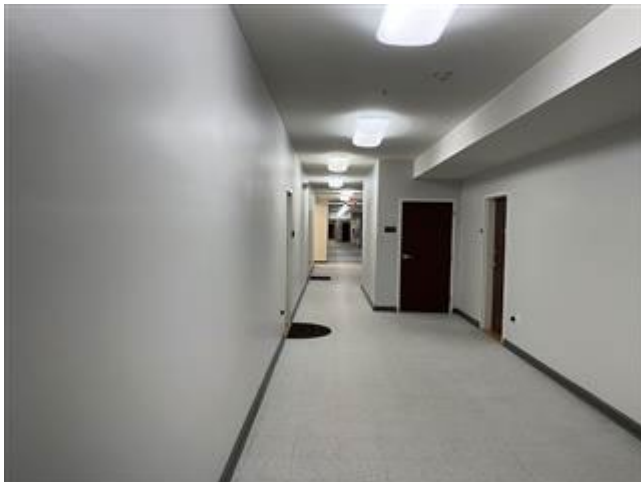
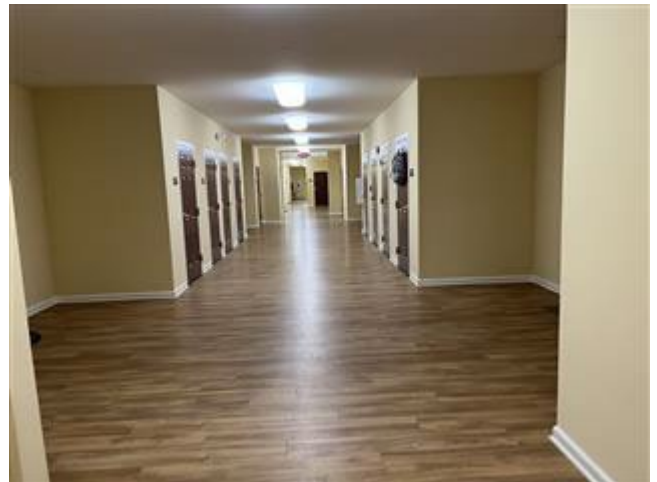
Corridors. The corridors in the condominium buildings consist of four (4) floors and with two (2) types of flooring, including vinyl tile, LVP (luxury vinyl planks). Listed below are the major corridor components that we have included in the Reserve Analysis:

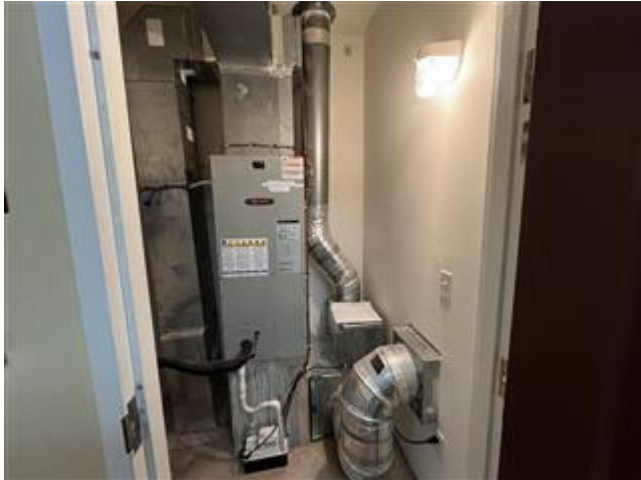
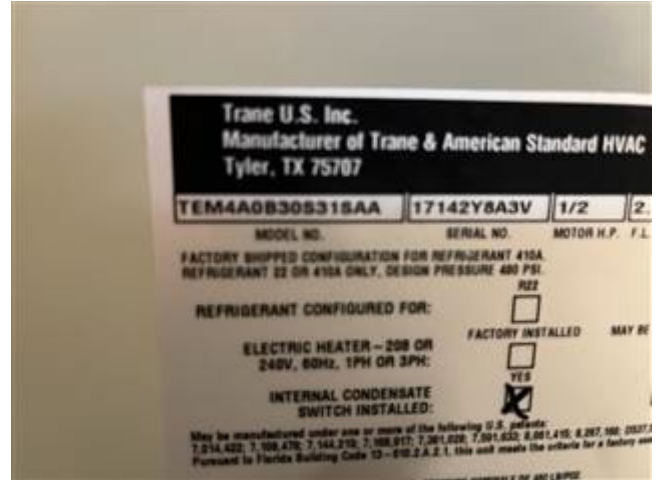
Split Systems. The Association maintains the condominium buildings split-system HVAC units. The systems include a furnace, coils, and a remotely located compressor. The systems are reported to be in good working order.

These systems provide heating and cooling and are normally controlled by one thermostat per system. Furnaces, fan boxes, or fan coils are normally located within the building and push condition air through ductwork. Compressors are normally located outside at the ground level or on the roof.

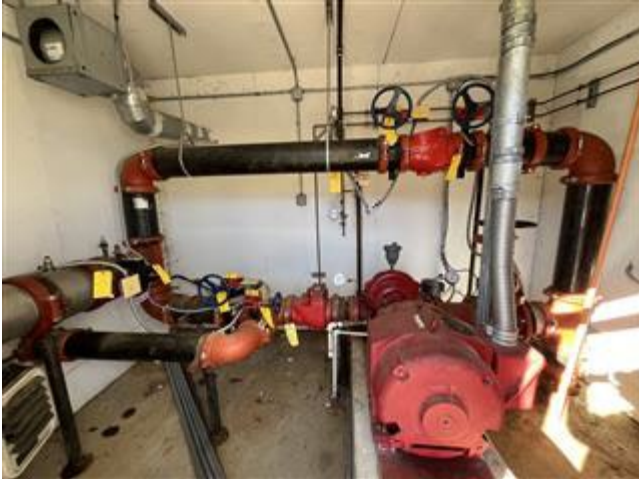
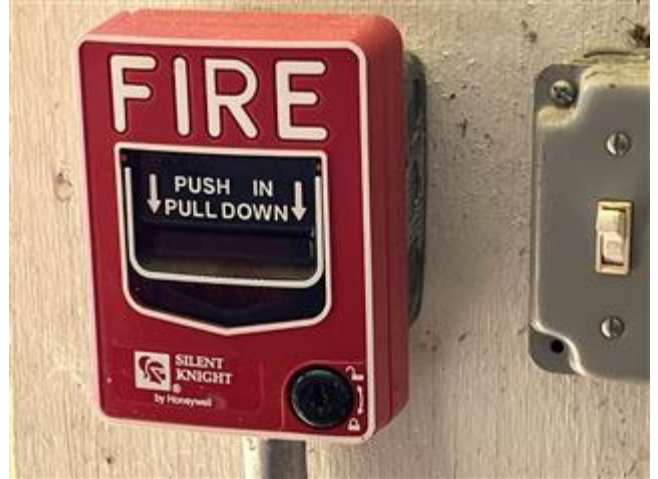
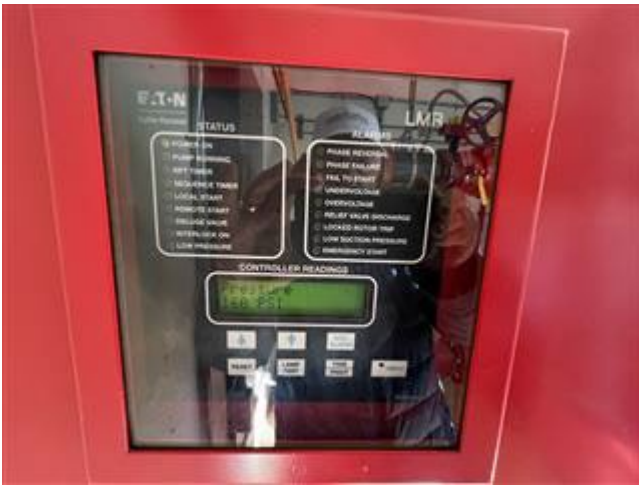
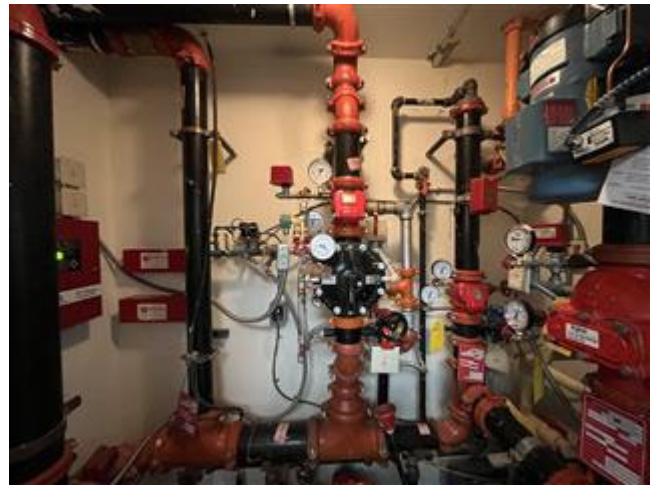
Fire Safety Systems. The Association maintains the community buildings wet/dry fire safety system that includes sprinklers and alarms, which are reported to operate normally. Testing and inspection of fire safety systems are not included in this study.
