RE: Village of Fountainview Condominium Association – Newark, DE

Stone and Vinyl Replacement Project - Progress Report #2

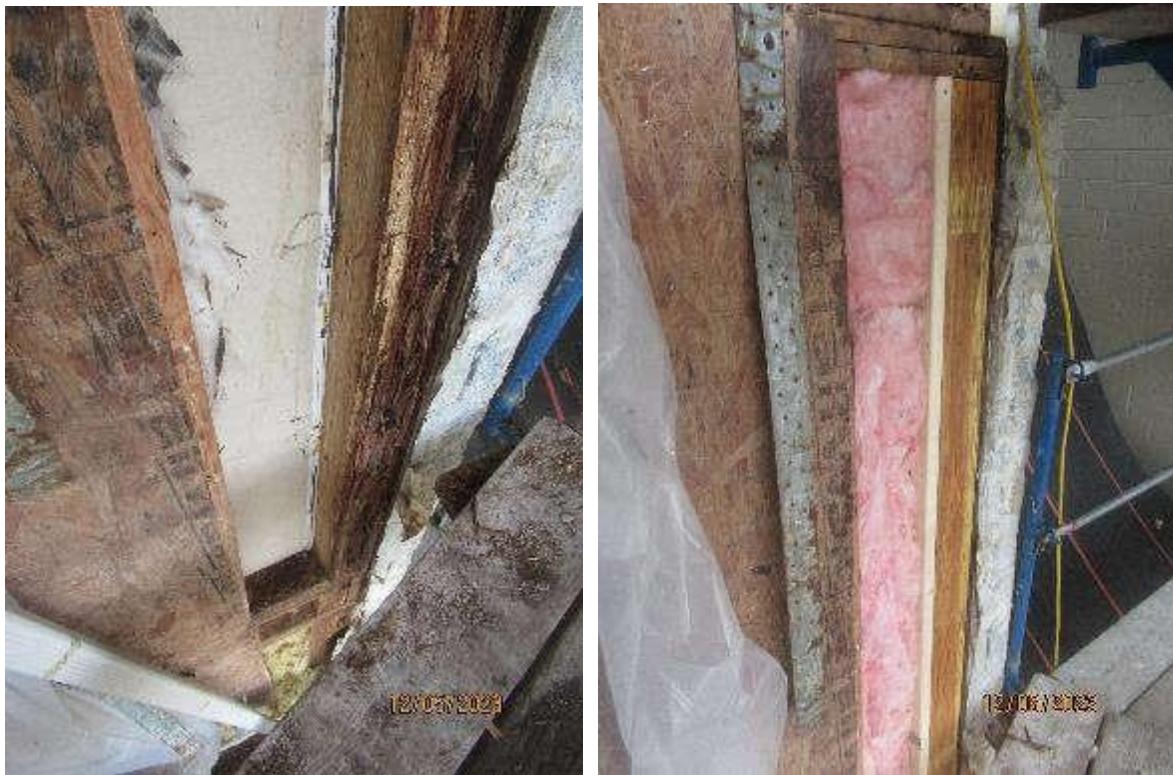
**Unit 216 North Elevation – PSL Column has been replaced at the corner by the CMU wall.**

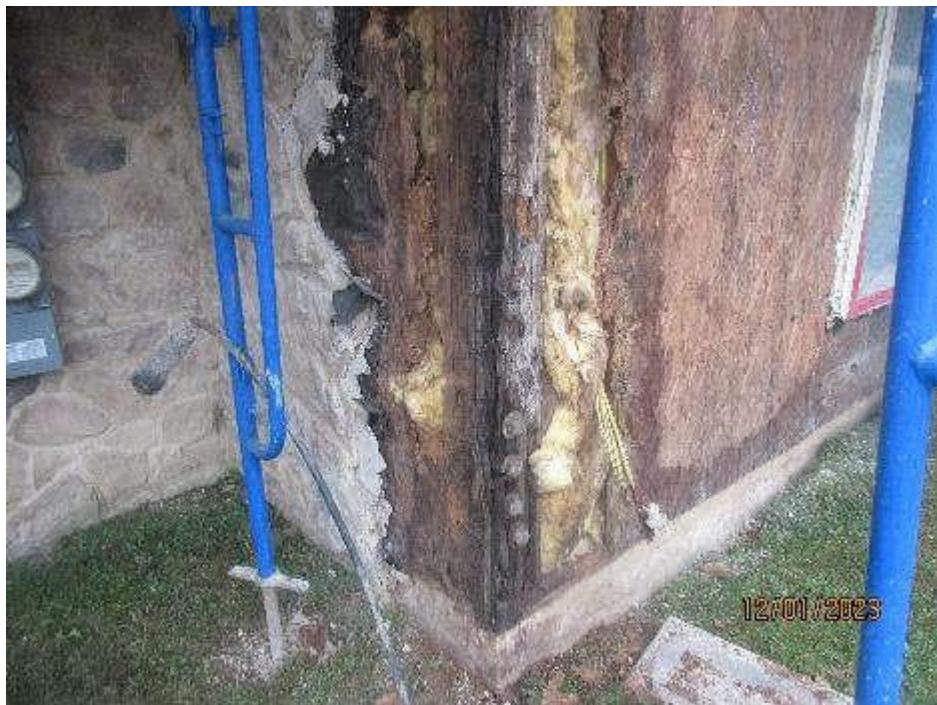
- o Wood components behind the stone veneer were observed to be significantly more damaged than behind the vinyl siding. The inside and outside corners appear to show the most damage.

Unit 116 North Elevation – Typical damage found at the outside corners at the North Elevation.

- o Damaged OSB sheathing is being removed and replaced with new CDX plywood.
  - o Falcon anticipates that similar conditions exist behind the cladding on majority of Building 3000 including the areas outside the scope of work.

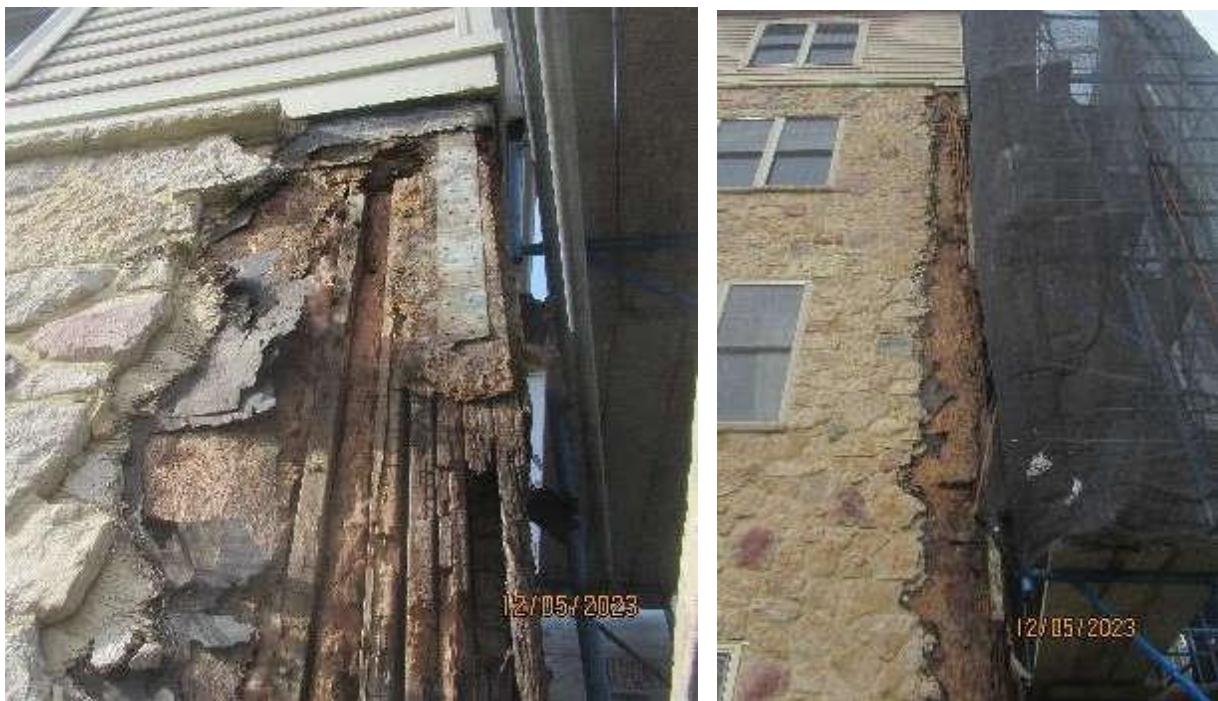
Damage at Northeast corner of Building 3000.

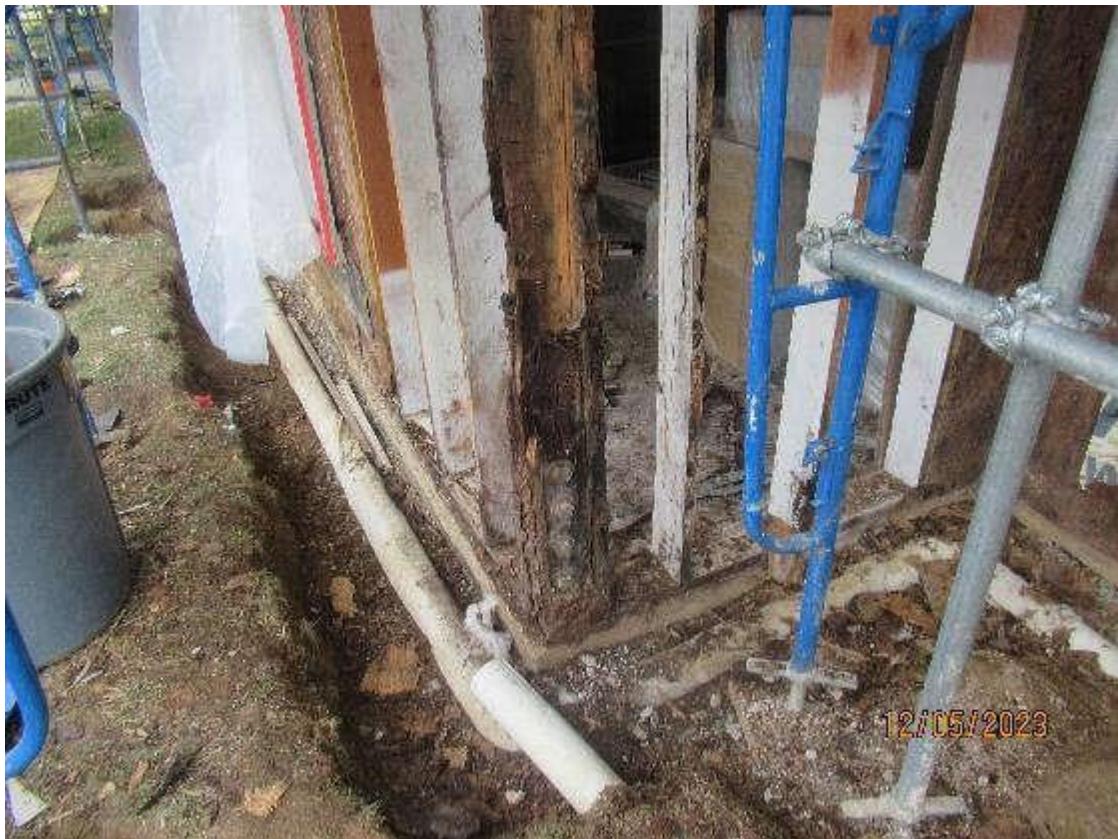
**Unit 115 North Elevation – Damage at the outside corner at the West side of the unit.**

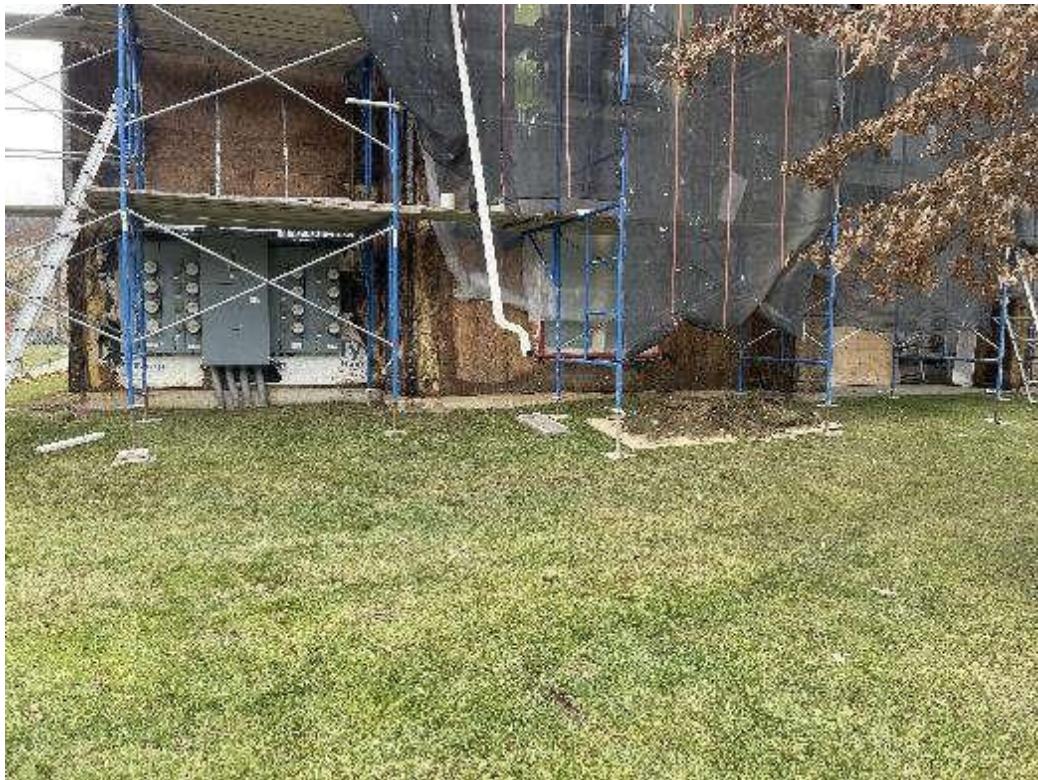
- The foundation on the Northeast side of the 3000 Building is above grade and does not require the Foundation Waterproofing Detail while the Northwest and West side of the 3000 Building contains a foundation that is below grade and the Foundation Waterproofing Detail will need to be incorporated. The board shall decide whether they want to continue the Foundation Waterproofing Detail along the Northeast side of the 3000 Building for aesthetic purposes.

Northeast Side of Building 3000 – Foundation is above grade. No Foundation Waterproofing required.

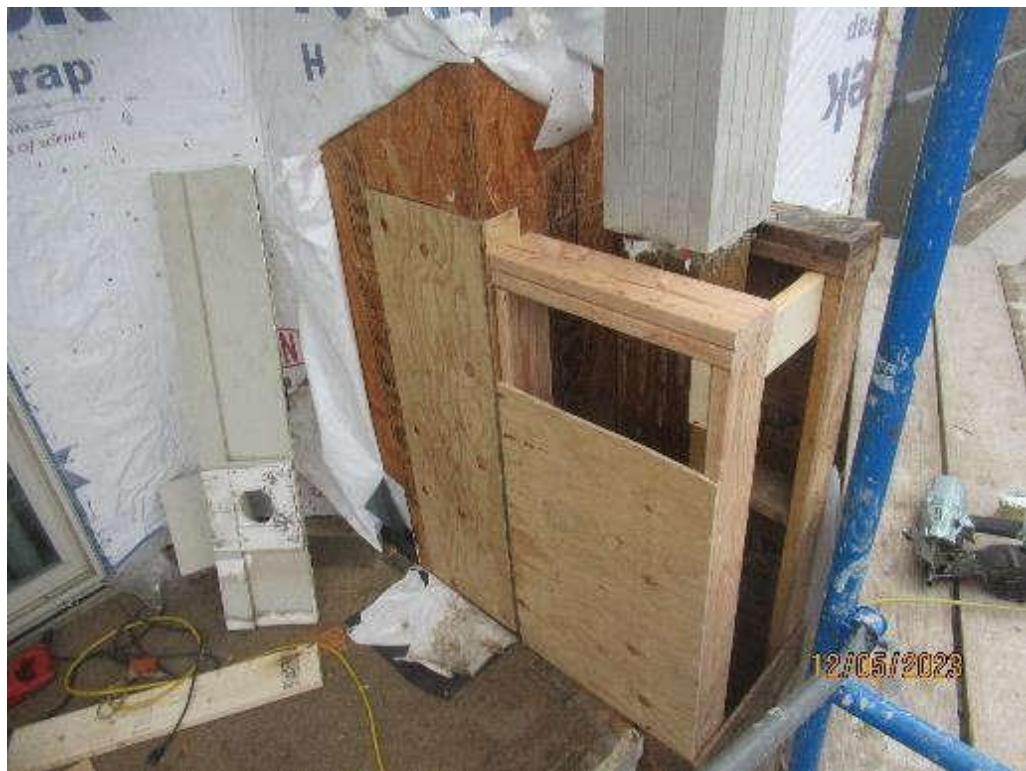
Unit 416 North Elevation- Wood replacement at the right-side deck column.

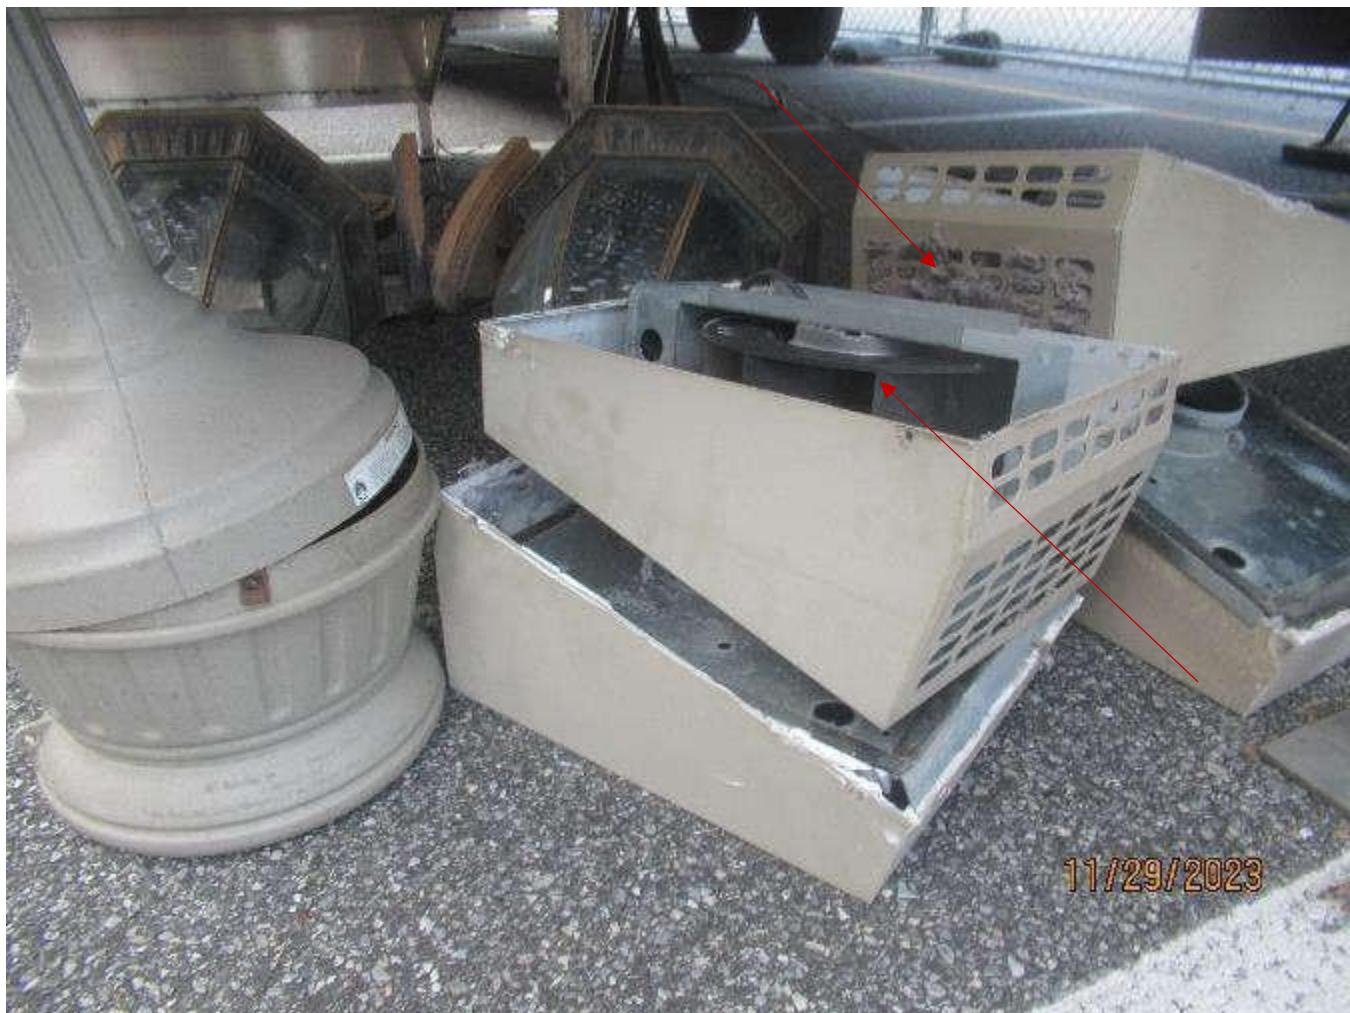
While on site, it was noted that the existing dryer vent covers were trapping lint. Some dryer vents were observed to be installed with a built-in powered fan that essentially traps lint as it has no way to escape. The existing dryer vent covers do not contain a removable lint trap which could cause a potential fire hazard. Falcon has reached out to the manufacturer (Fantech) of the covers and learned that these covers are not approved for use with dryer vents. The exhaust duct lines for the dryer vents also appear to be more than 35 feet in length which fails to comply with IRC 2018 code M1502.4.5.1 (shown below) that states that the exhaust duct shall be no more than 35 feet of length not including fittings. Where fittings are used, the maximum length shall be reduced.

Existing dryer vent cover with built in powered fan. Existing dryer vent cover showing trapped lint.

Falcon also notes that the Code allows duct length to be dictated by the Dryer Manufacturer's Instructions and some Manufacturers make models for longer exhaust runs. The community could specify allowable dryer models without changing the exhausts or adding booster fans if they choose to.

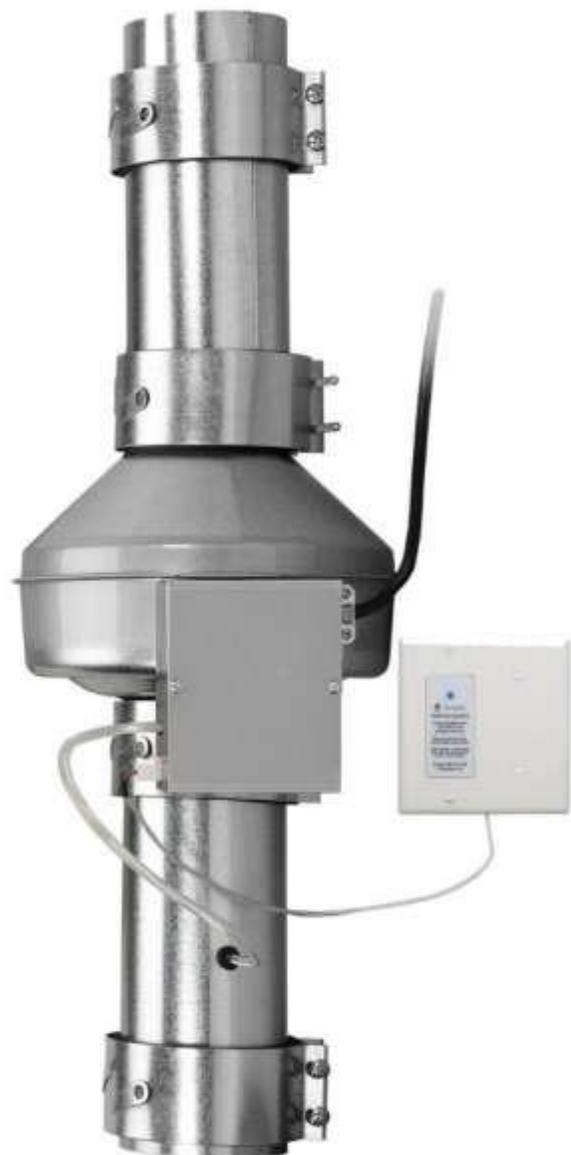
**Photo showing (DEDPV-705 UL Listed Ventilator) in-line dryer vent booster fan with removal lint trap.**

The manufacturer of the existing powered vents does have an in-line dryer vent booster fan with a removal lint trap option that supports duct runs up to 125 linear feet. This is just a power fan, not an exterior vent cover meaning we would still need an exterior dryer vent cover to install this product and bring the dryer vent exhausts into conformance with the current code for new construction. If the Association would like, Falcon can get pricing from National for this change. Pricing would include a new booster fan (about \$400 each), exterior dryer vent cover, and labor. Please advise how the Association would like to proceed. It should be noted that we were not aware of this pre-existing condition, so this was not budgeted for during the bid process.
