CAPITAL RESERVE STUDY – DRAFT
VILLAGE OF FOUNTAINVIEW
FOUNTAINVIEW CIR AND FOUNTAINVIEW DR
NEWARK, DE 19713

FOR:
VILLAGE OF FOUNTAINVIEW CONDOMINIUM ASSOCIATION
c/o MARY TUCKER
COMMUNITY MANAGER

JULY 21, 2020

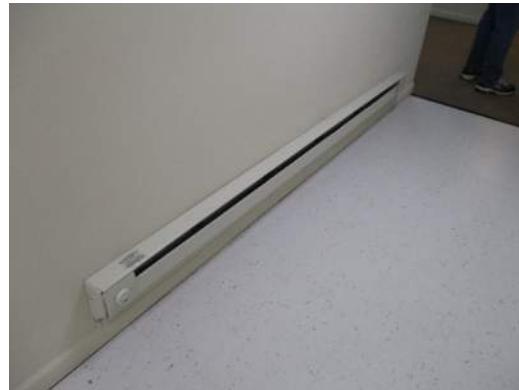
Baseboard Heaters:

Electric baseboard heaters are located by all condominium building entrances. The heaters appear to be in good working condition and no issues have been reported.

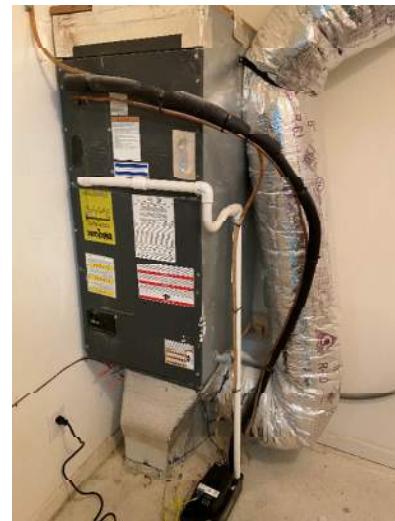
Split System AC:

One split system AC is located at each condominium building to serve the corridors. The air handling units are located in fourth floor mechanical closets while the heat pumps are located at the rear of the buildings. These units have all been replaced within the last three years. The units appear to be in good working condition and no issues have been reported.

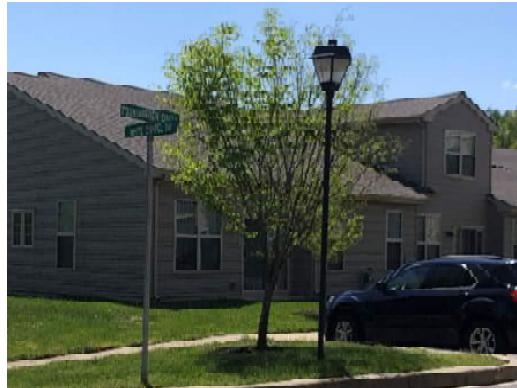
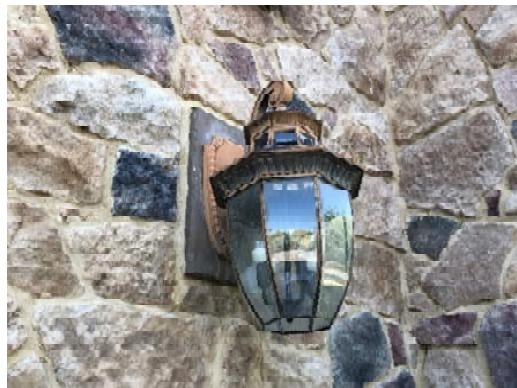
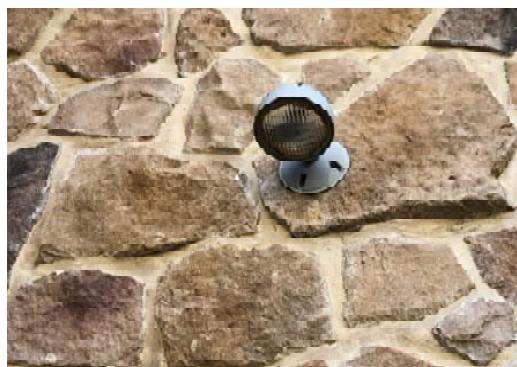
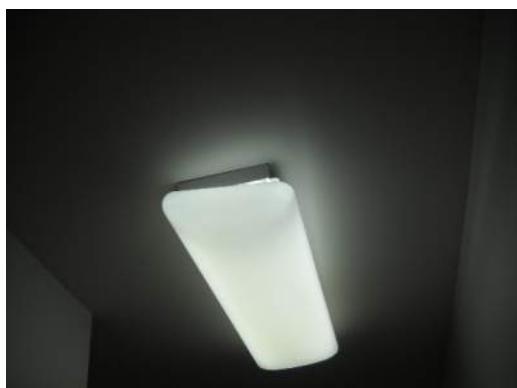
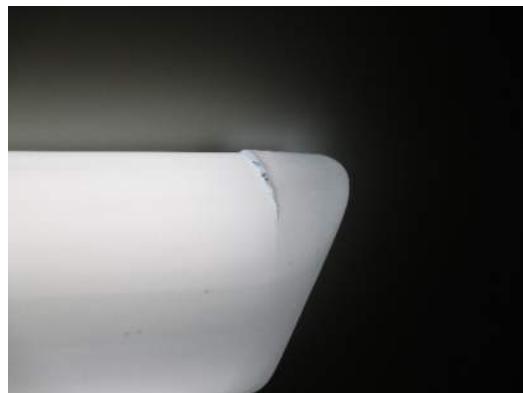
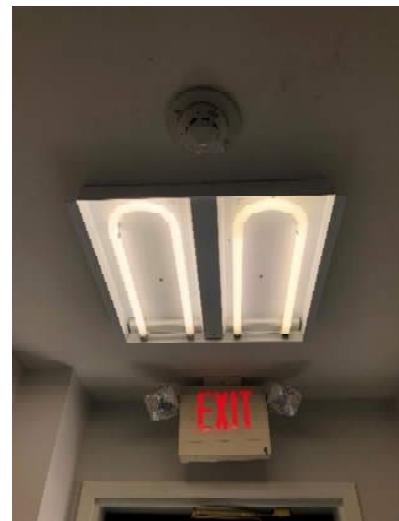
Building exterior and interior lighting have expected useful lives of 15 to 20 years. Replacement of the corridor light fixtures can be expected in the upcoming years. The exterior lighting is generally in good condition and we have, therefore, extended their life expectancy by an additional 5 years. However, replacement of the light fixtures is highly dependent upon community expectations, funding, maintenance, and board guidance.

The electrical equipment should be inspected and maintained regularly.

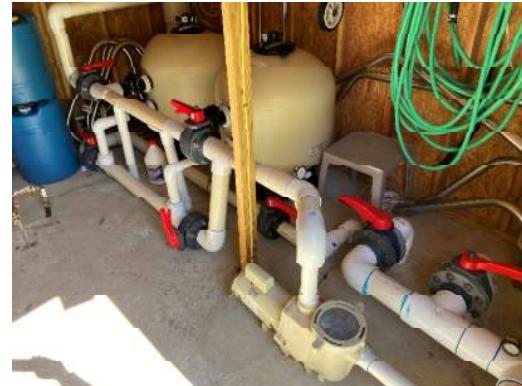
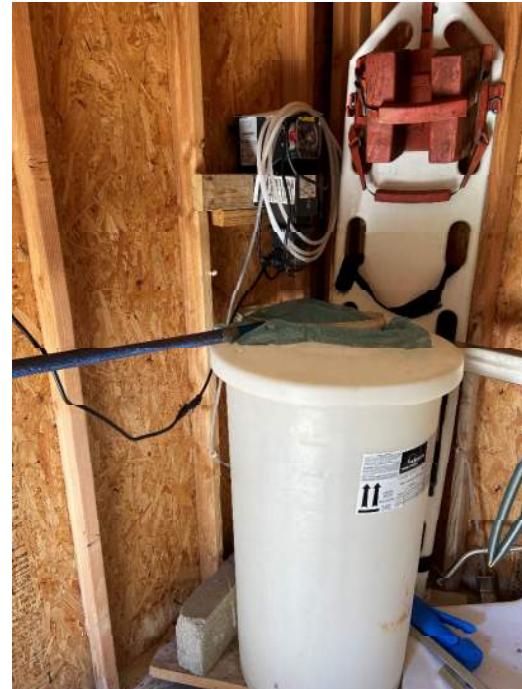
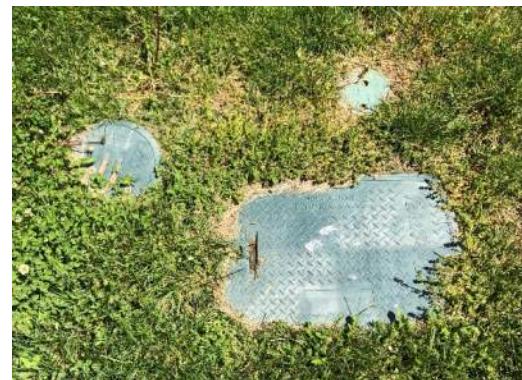
The pool equipment and irrigation valves have estimated service lives of 15 years. Both systems are nearing the end of their useful life, however, the pool pump is planned to be replaced this year. Remaining pool equipment and irrigation valve replacement is anticipated within the next 3 years.

We recommend regular maintenance to extend the useful service life of these components.
